LAIGHILLS PARK INSPECTION

DOC REF: 12770/DK/198 REVISION A

CLIENT: Stirling council

ENGINEER: Millard Consulting
Seabraes
18 Greenmarket
Dundee
DD1 4QB

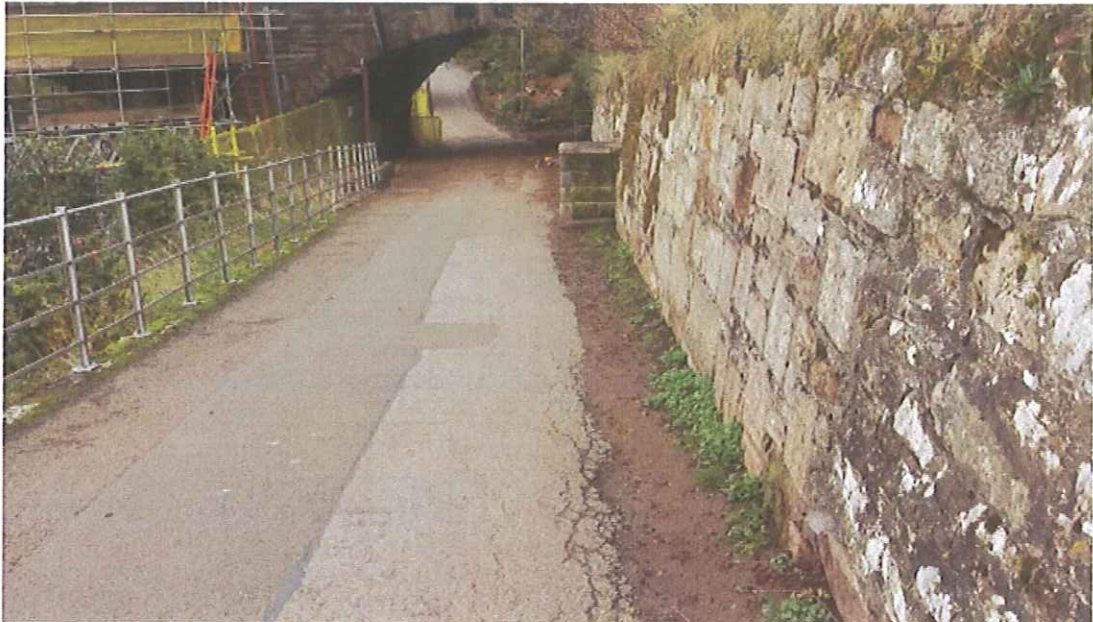
Photograph 2

A stone retaining wall extends down the north side of the access to the railway bridge. The wall has been repaired in the past. The surfacing at the foot of the wall has been eroded. It is assumed water coming down and also through the wall has gotten below the surfacing at the interface, weakening the material and causing it to break up.

- Without further engineering investigation/assessment, it is our opinion that the surface would benefit from complete replacement and reshaping to crossfall from north to south, ie

towards Allan Water. The poor seal along the north channel between surfacing and retaining walls has resulted in a breakdown of the bituminous materials and shall only worsen. A kerbline should be installed in front of these stone retaining walls to allow the surfacing to seal properly against a smooth flat surface. A concrete infill can be laid between kerb and wall. This will allow any water to flow over the surface of the concrete onto the road. Reshaping crossfall shall promote the water to flow to the south channel where it is drained by existing gullies or direct run-off. The drainage system should be regularly cleaned to prevent future maintenance problems. Any soft spots should be completely removed and reconstructed.

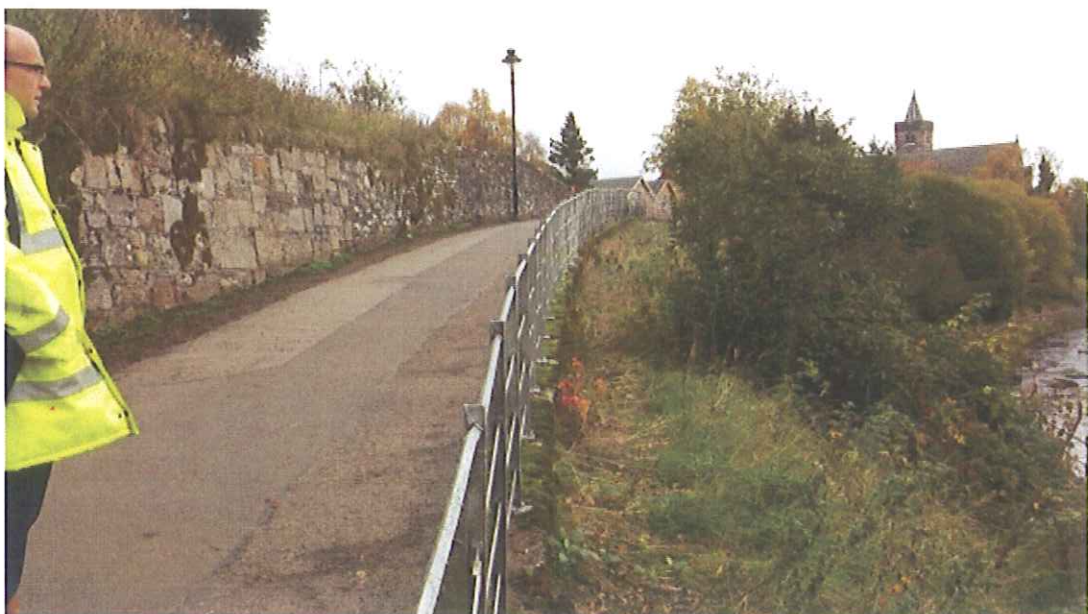
Photograph 3

On the opposite side from the stone retaining wall the road is also retained by mass concrete wall, with a handrail on top. No kerb upstand in this location, therefore water flows directly over the retaining wall to the grass slope.

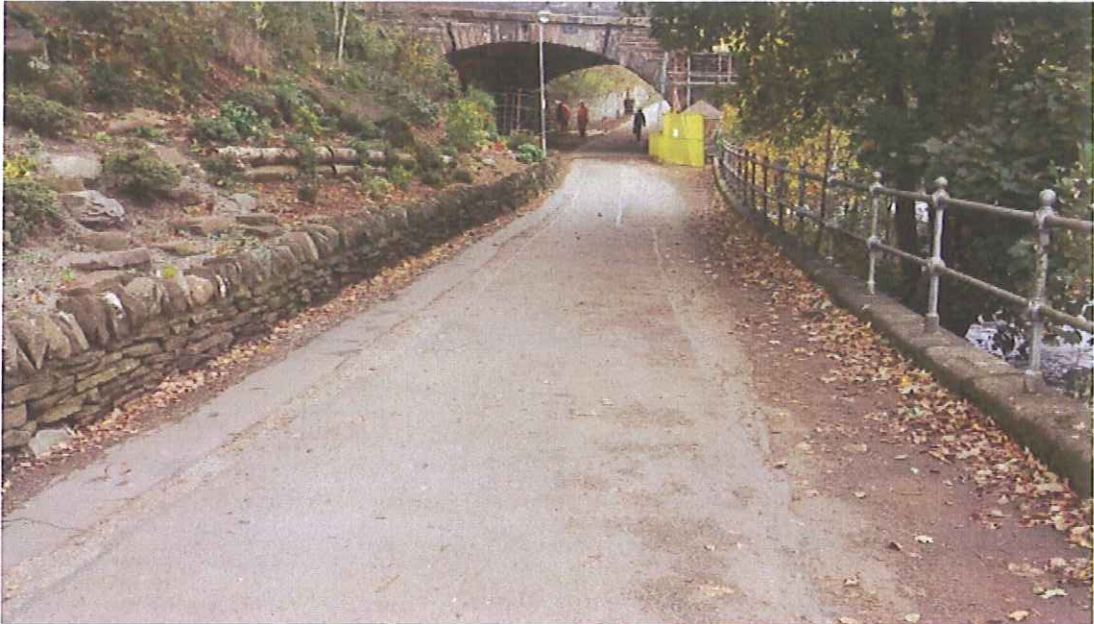
Photograph 4

The road passes below a railway bridge, this point also being the low point of the access, then rises towards the footbridge over Allan Water. The north side has a low stone dyke retaining wall to the rock garden, again there are similar problem with water at the interface between the two although not to the same extent as before. The south channel is formed by a concrete coping stone on top of a retaining wall next to the Allan Water. The surfacing is similar to the previous section with numerous areas of patching and reinstatement.

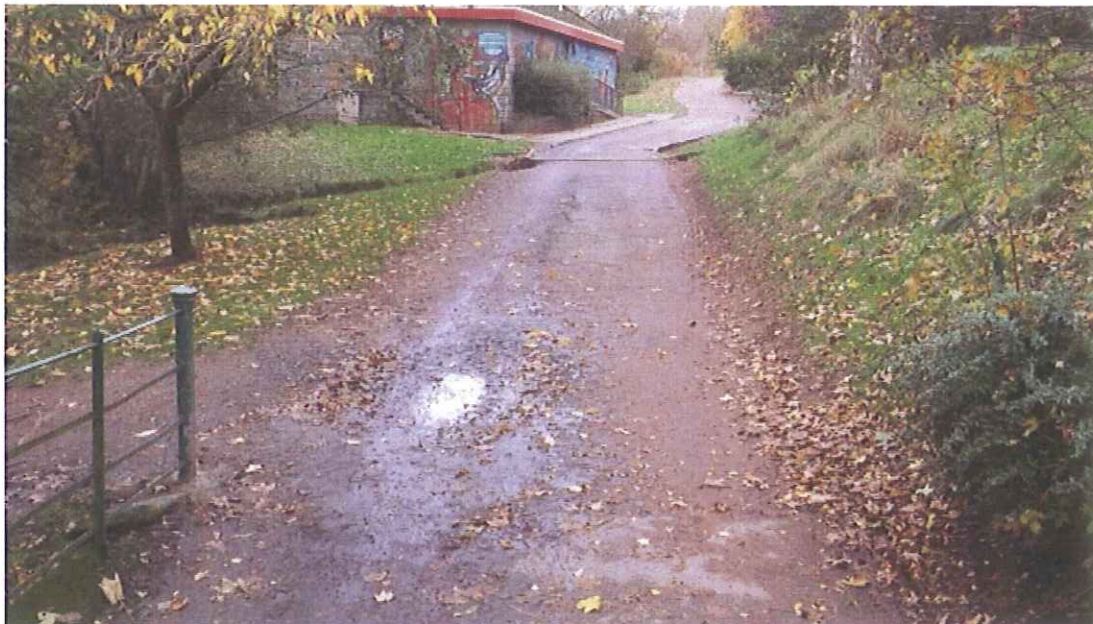
This access is in poor condition, most likely due to standing water. Water also runs from the adjacent slope across the road towards the river. The low point shown in Photograph 6 between the bridge and the footbridge access has become eroded and now holds water. The bituminous surface is in poor condition. This section of road would benefit from kerbing both sides, a ditch or trench to prevent water and silt run-off from the slope and an outlet for drainage. The foundation of the access would appear to be firm, with no soft spots becoming visible at the surface. The bituminous surfacing however requires replacement. It should also be thick enough to cope with light goods vehicles and maintenance vehicles.

- Kerbing to both sides with 125mm upstand. Bullnose kerbing to be installed at the interface with the bridge
- Gravel filter strip between slope and kerb – create fall in trench towards bridge
- New surfacing 100mm thick (2 layers - overlay) in crossfall toward slope and filter drain
- Form drainage outfall to the burn

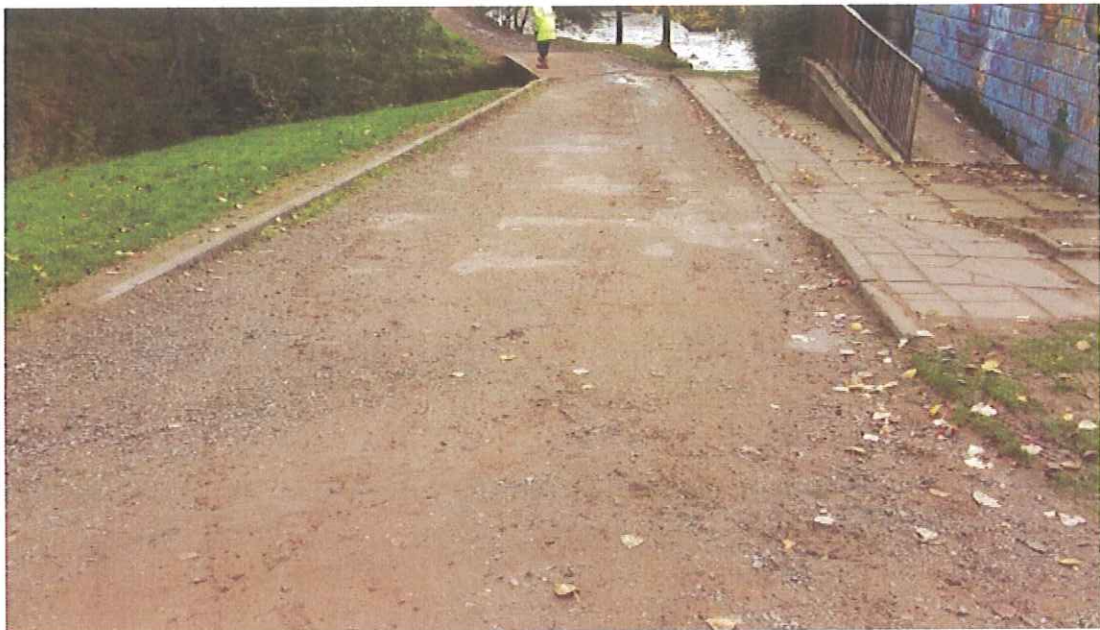
Photograph 7

This access has been previously kerbed and surfaced. The surfacing suffers from surface water flowing down from the playpark area and access tracks. The water appears to flow down to the bridge where it collects and finds its own way to the burn/river.

This has caused a build up of mud/silt/gravel along the channels and across the entire surface. There is a slabbed footway along the edge of the existing disused building. This is also in poor condition with many cracked slabs. There does not appear to be a drainage system installed to collect and dispose of surface water.

- New kerbing to both sides. Flush kerb to the north for direct surface water run-off, 125mm upstand along the footway, maintain dropped pedestrian access. Bullnose kerbing should be installed at the interface with the bridge
- New filter drain or swale along the north verge with outfall to the burn
- New surfacing 100mm thick (2 layers), plane off existing surfacing, replace at existing levels
- Replace slabbed footway
 - A drainage system should be installed to the west to protect the access from silt/run-off from the higher level tracks (see item 5).

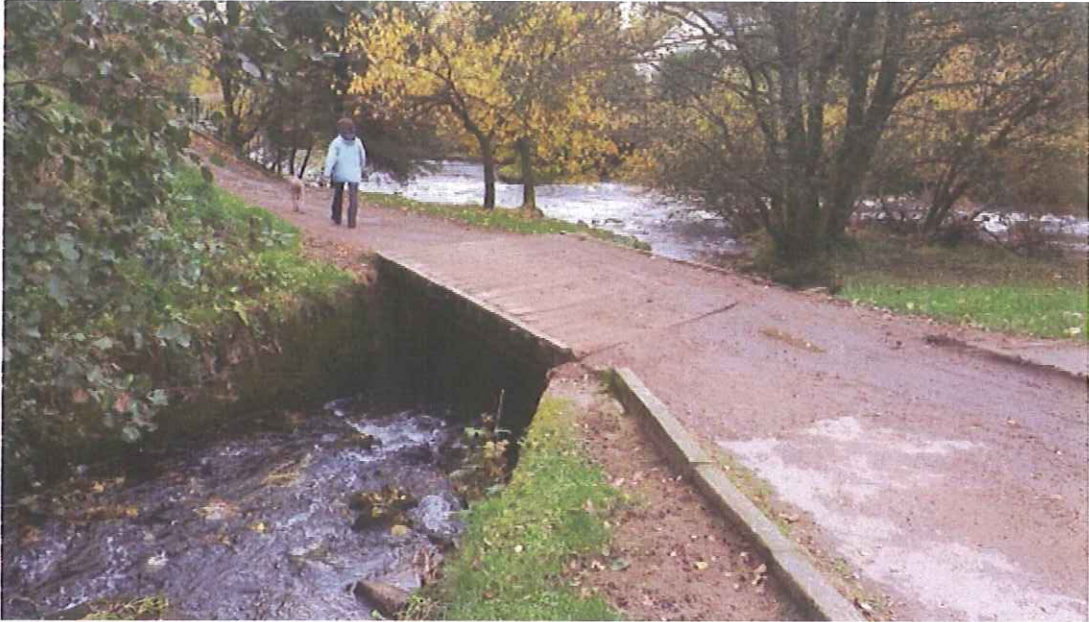
Photograph 8 – The bridge viewed from upstream

- A new bridge structure be constructed to replace the existing. The form of construction should be decided by the Client and Architect as it may be desirable to have a timber bridge or a timber deck on steel beams. We would be pleased to provide additional information if required.

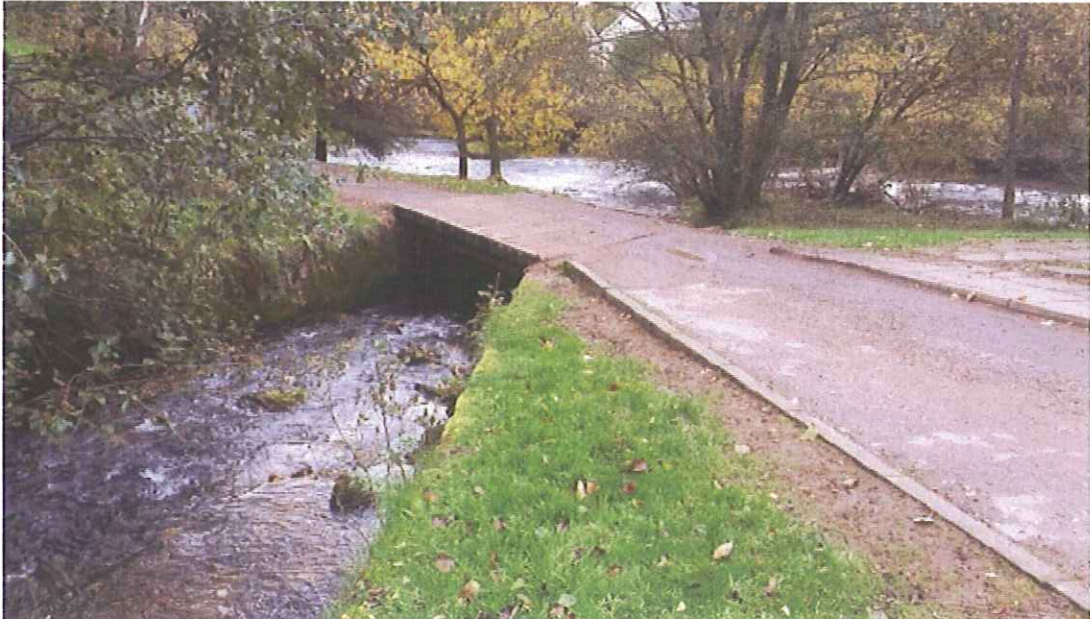
Photograph 9 – The bridge viewed from upstream

The photographs taken upstream give a general indication of the approaches to the bridge which are generally poor. The run-off from the access drains into the burn at each side of the bridge. The ground on either side was found to be uneven with standing water noted.

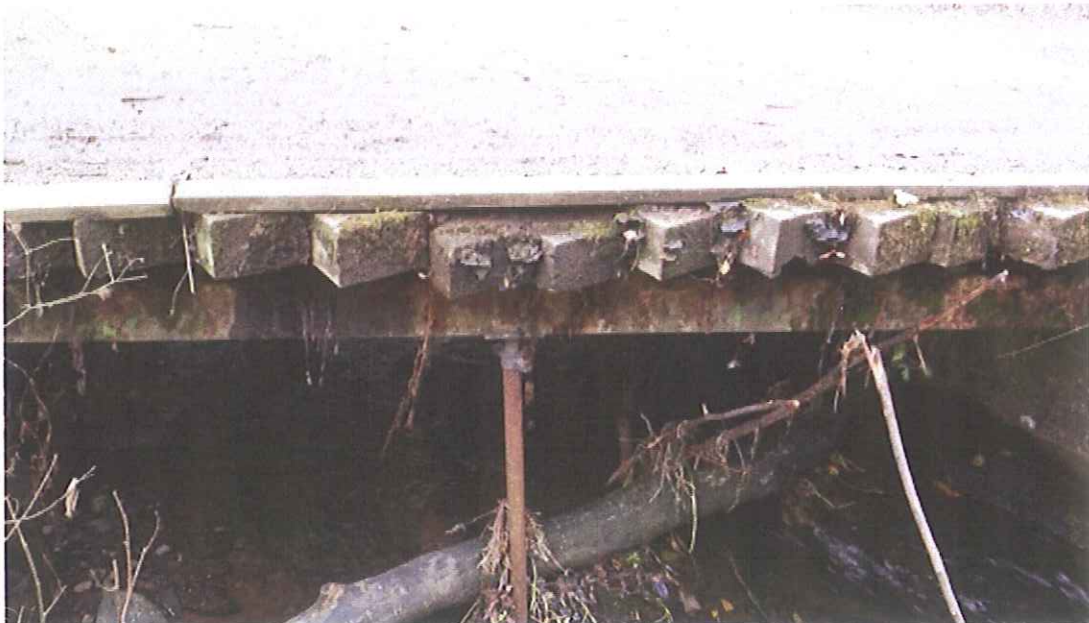
Photograph 11 – Prop

As can be seen in photograph 11, an acrow prop has been used to support the downstream end of the bridge. We do not know how long the prop has been in place. However, it was noted that debris was building up behind the prop.

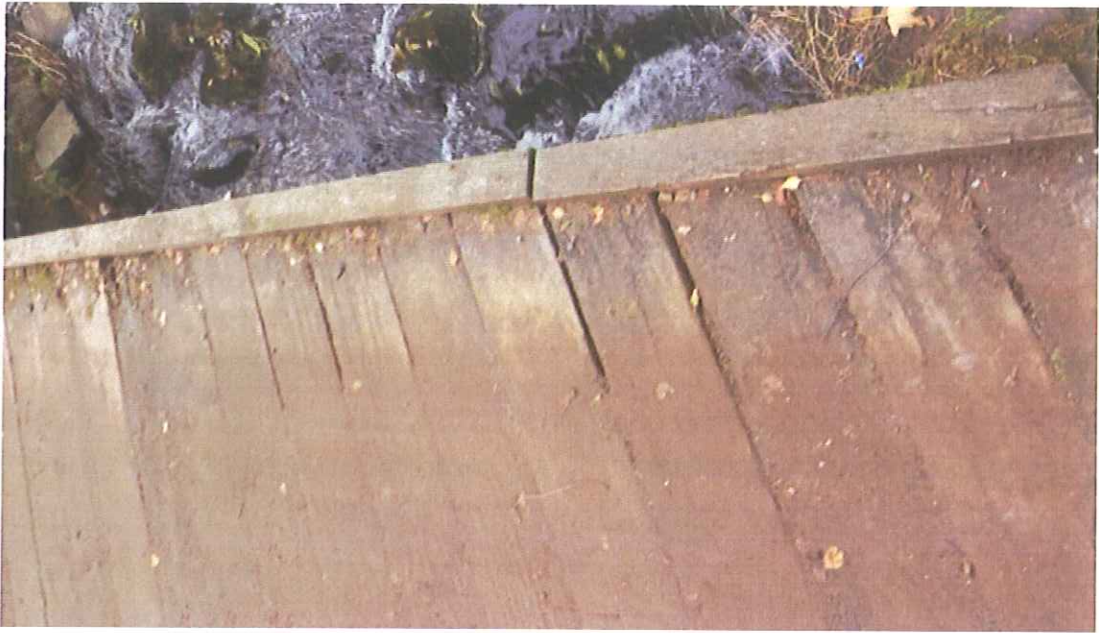
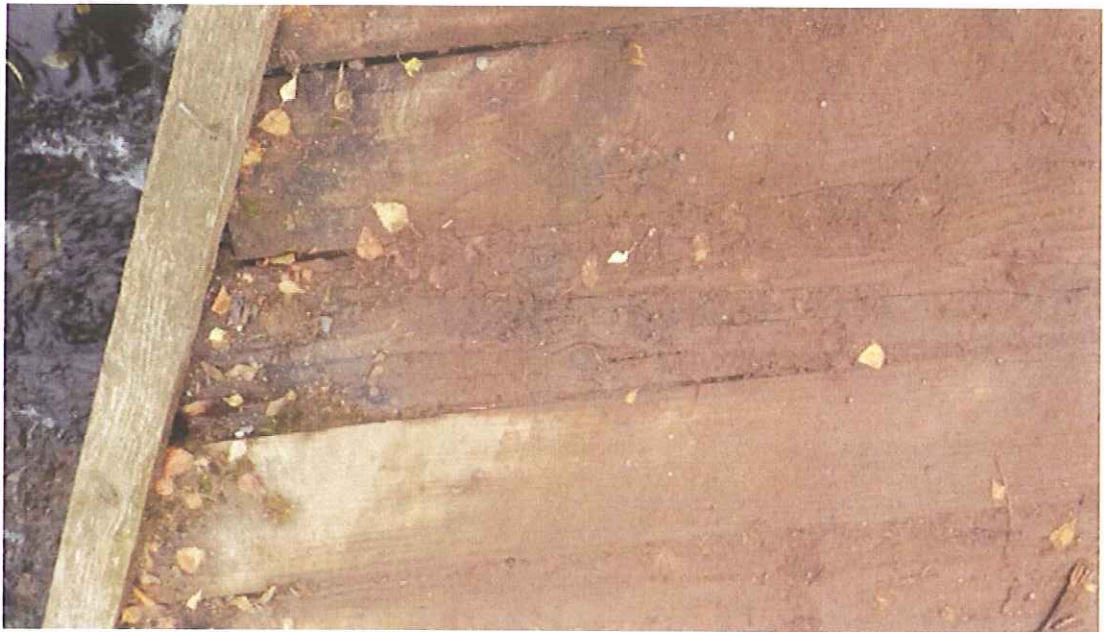
The timber sleepers that form the deck were found to be in poor condition. The deck was noted to move in places when a vehicle was driven over it. Some of the sleepers have split in places. Photographs 12/13 show the gaps between and condition of the sleepers

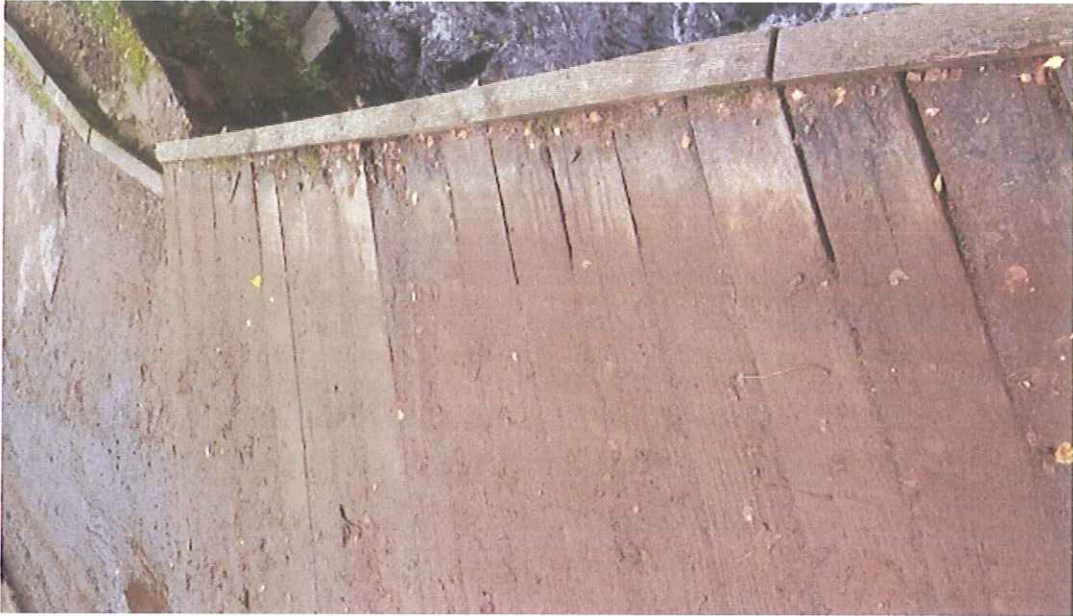
Photograph 14 – Downstream edge of the deck

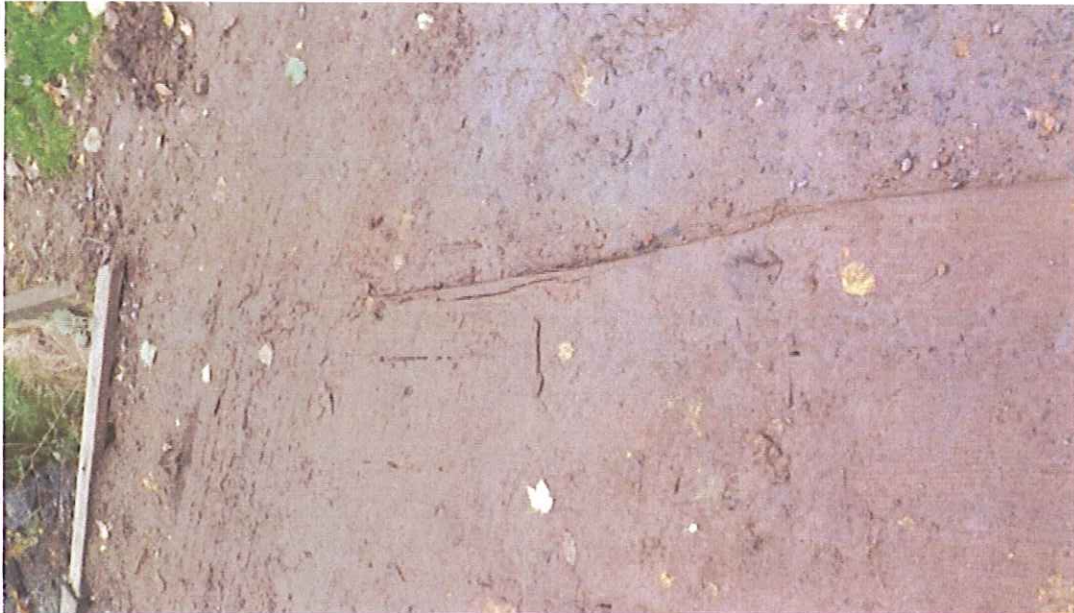
Photograph 15 – Condition of sleepers at point with road surface

It is in our opinion that the bridge has reached the end of its useful life and requires to be replaced. Consideration must be taken of the requirement to provide barriers/handrails. Although we are aware this will detract from the aesthetic feeling of a small walkway over a burn.

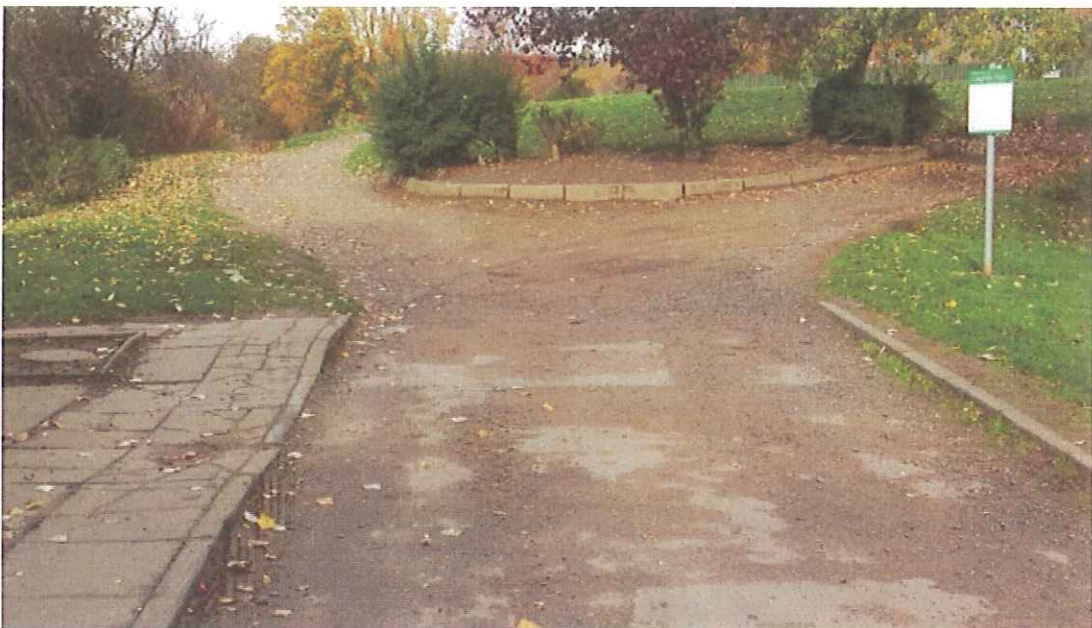
Photograph 16

Once across the bridge and entering the park, the access road split 2 ways. Vehicle and pedestrian access continues ahead to the west and pedestrian only access heads north to higher ground. Both tracks create boundaries to the children's play area. The junction of the tracks in this area collects surface water. Water is directed towards the bridge. Erosion has dropped the surface level of the tracks, creating a dishd uneven profile. The small area of planting (top centre of photograph) in the centre of the junction has been kerbed previously but is now in poor condition. This area could be better used to prevent water flowing from the grassed area over this junction.

- New kerbing to landscaping
- Ditch or filter drain to be installed behind the landscaping – outfall to burn
- Kerbing of access road to be continued throughout this junction area
- Full reconstruction of track. Levels to avoid excavation if possible due to high level of rock. Further assessment of CBR% values for track foundation required. 100mm surfacing (2 layers)
- All surfaces shaped to fall to the north directing water to the burn and away from the pavilion

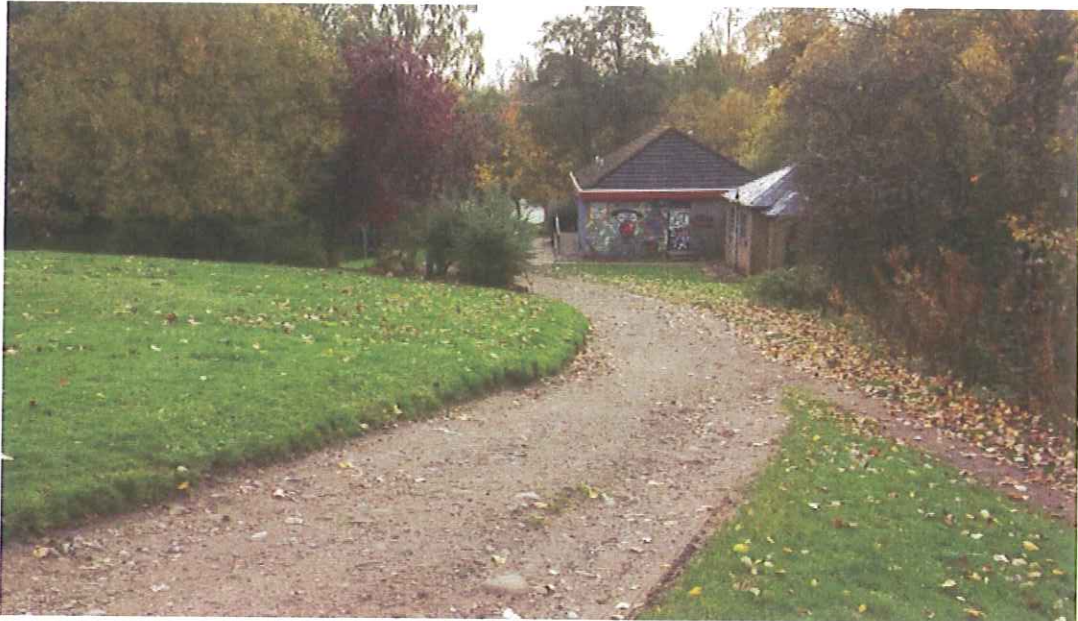
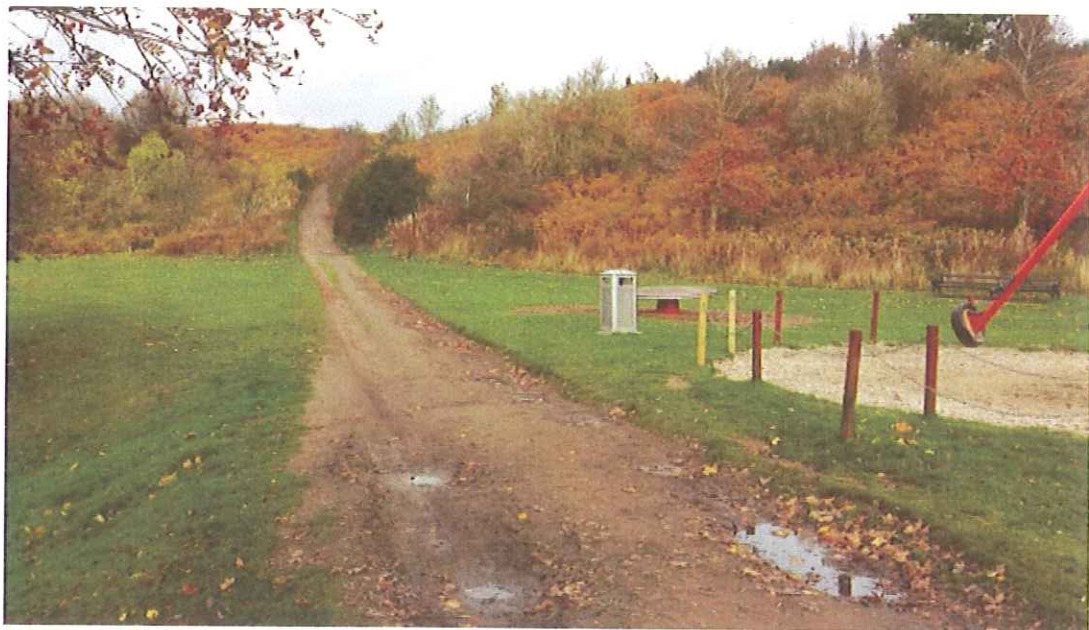
The existing track along the western boundary of the children's play area is in poor condition with a rutted, uneven and loose surface. By inspection the track is regularly used

Photograph 17 – Looking back towards pavilion

Photograph 18 - View northwards to pitch access

- Flush kerbing installed to both sides of the track
- Full reconstruction of track. Further assessment of CBR% values for track foundation required. 100mm surfacing (2 layers)
- Alternative construction using crushed stone, sealed with whin dust could be used with shorter design life

- Ditch or swale along the boundary with the play area, feeding down to the burn to prevent water run-off to lower level riverside path (informal)

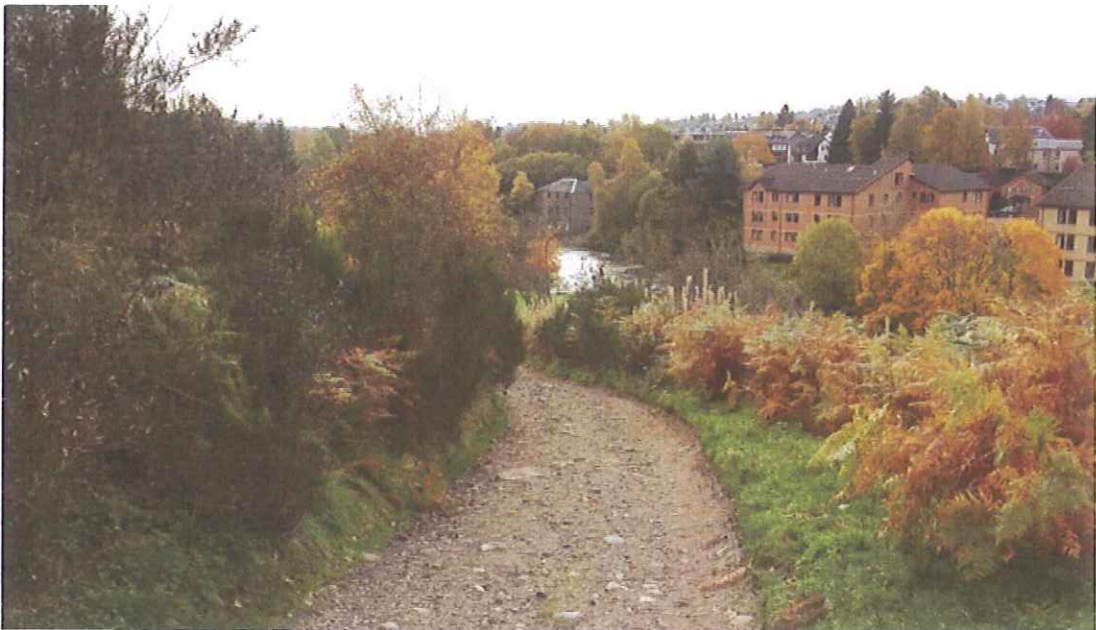
Photograph 19

The track leading to the upper level football pitch is in poor condition with a rutted, uneven loose surface. The track may have been constructed in crushed stone. The majority being washed out by surface water. This track acts as a water channel. No offlet /outlets are present. The vertical gradient is also very steep for vehicular access. The steepness may pose difficulties to any new construction proposed.

- Reconstruct track using type 1 sub-base material, sealed with whin dust
- Lay timber edging to both sides as a restraint to type 1 material
- Create regular offlet drainage to existing vegetation
- Given the steepness of the access and narrow width, this work may only be possible by manual labour
- The top area of the track should have a hardstanding area to prevent rutting through the clayey topsoil

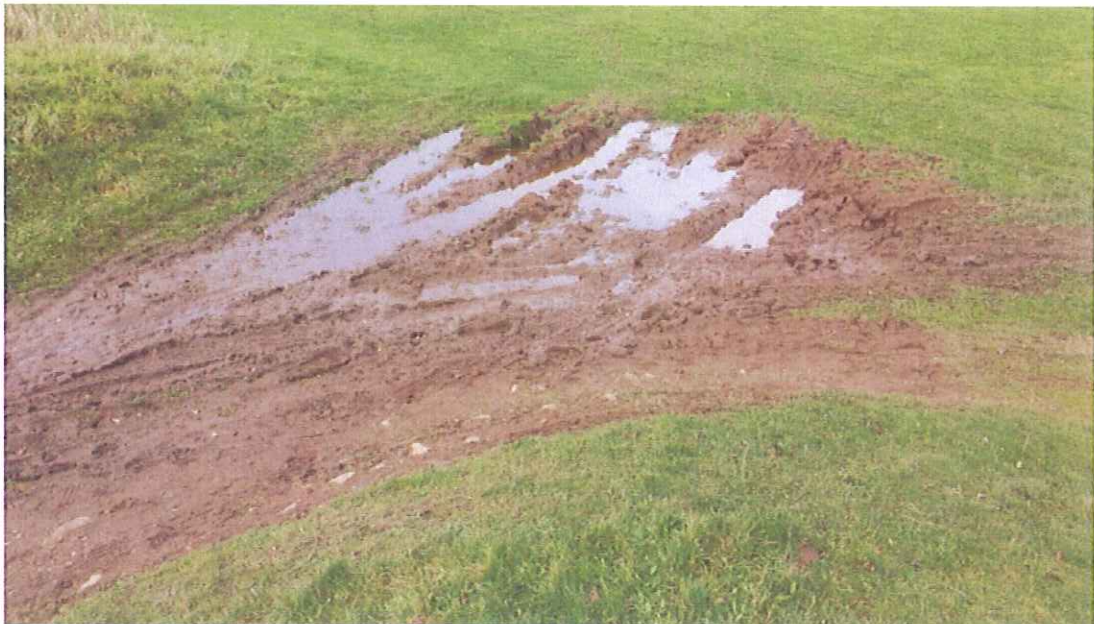
Photograph 20 – Top of access track

The area directly at the top of the access track has become very muddy from vehicular use. No path has been created at this point.

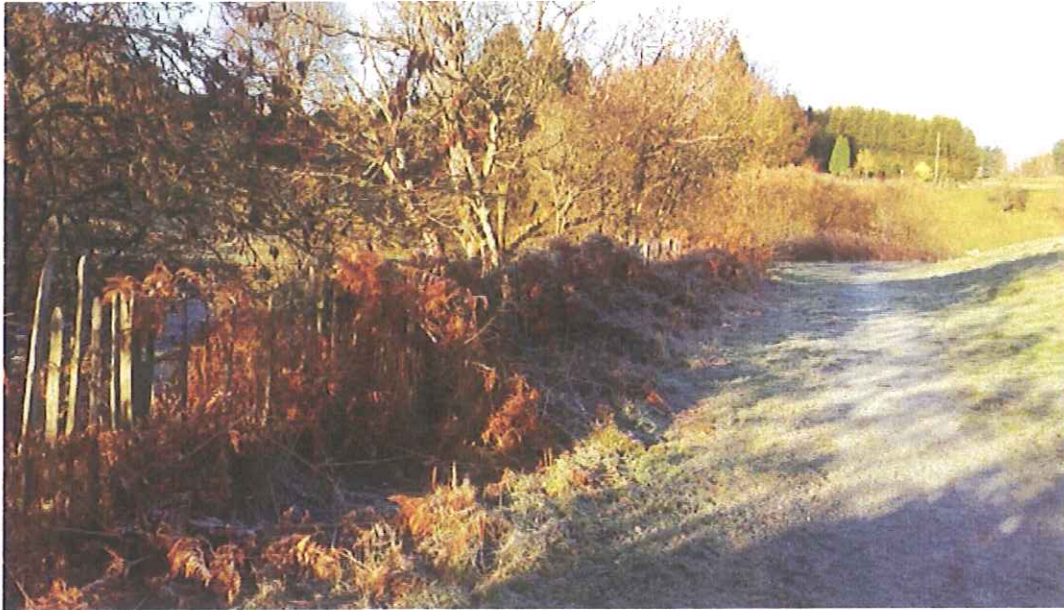
Photograph 24

Progressing around the pitch the path continues in grass. The chestnut pale fence between the pitch and path is in very poor condition, but poses no risk to pedestrians.

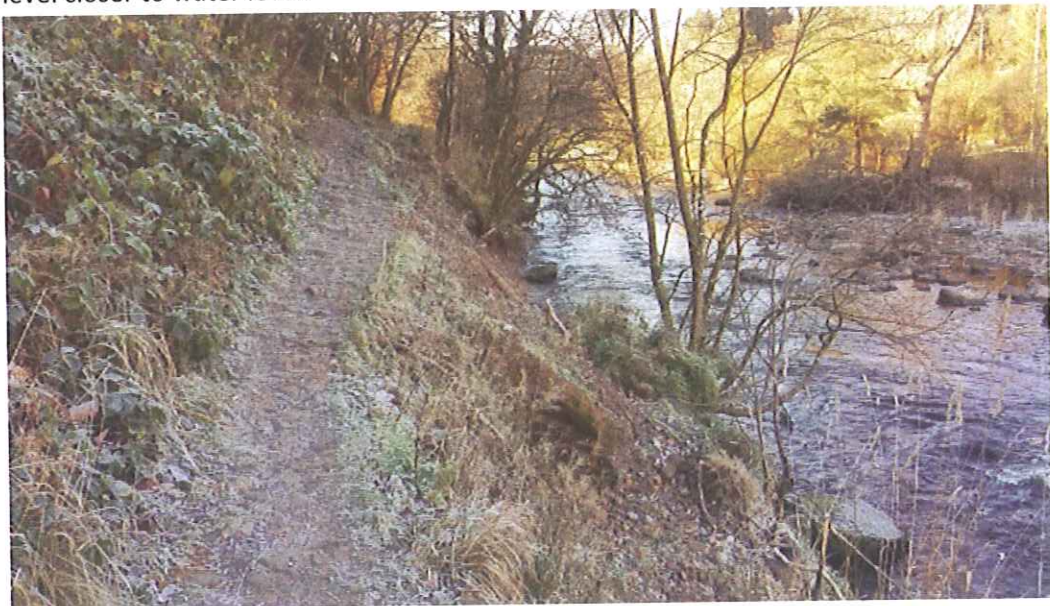
Photograph 27

The path narrows to less than 1m abruptly due to a land slip for a length of approximately 25m, where a section of the bank has fallen away. At this location the slope becomes even steeper and poses risk to the safety of pedestrians. There is little room for two people to pass each other without danger of falling. Beyond this slipped section, the path lowers in level closer to water level.

- One option to consider should be to close this section of path due to the danger posed by the narrowing path at the section where the slope has slipped.
- The alternative option would be to construct a retaining wall of gabion baskets with fence on top for the entire length to protect the slope and widen the path. Further engineering assessment will be required.

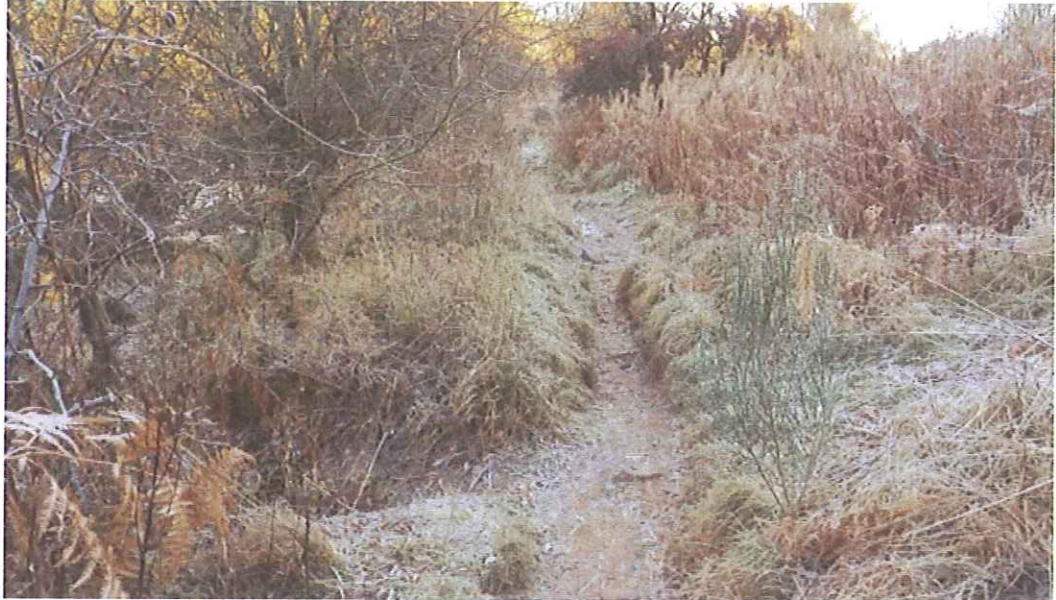
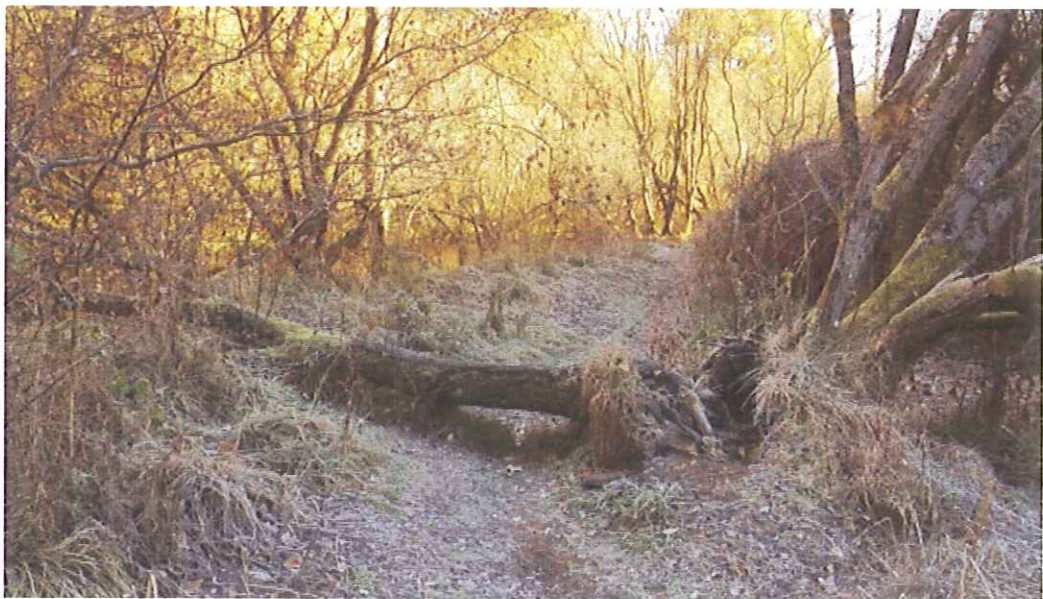
The path quickly becomes very rough and uneven as it progresses to the bend in the river, no more than single file width available with numerous tripping hazards and trees blocking the path.

- A new gravel path is required to follow the route of Allan Water, some clearance of scrub and trees will be required. This section, around the bend in the river could potentially be closed off and an alternative route taken (item 9.2).

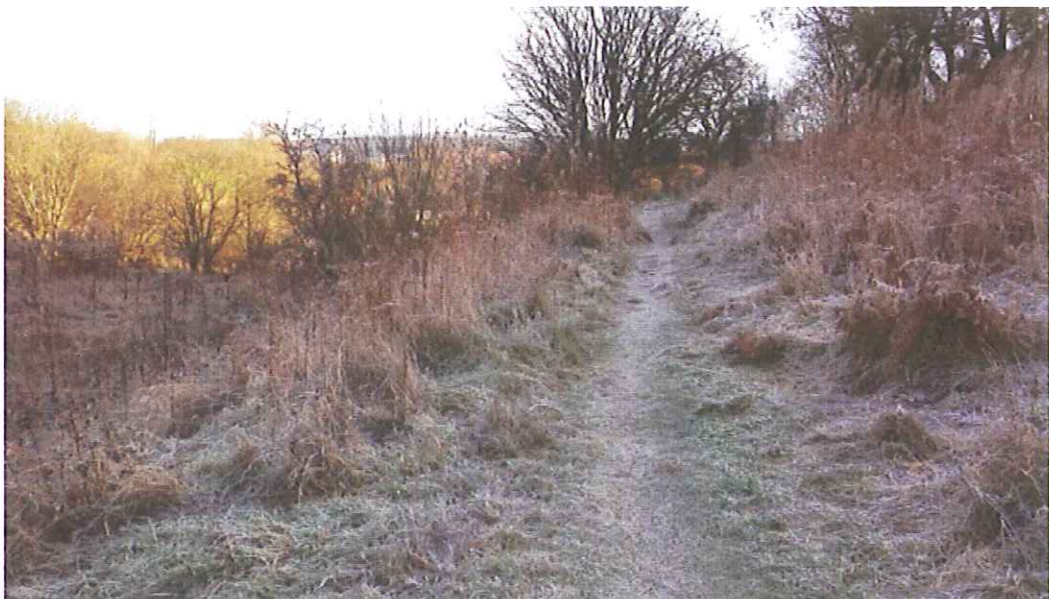
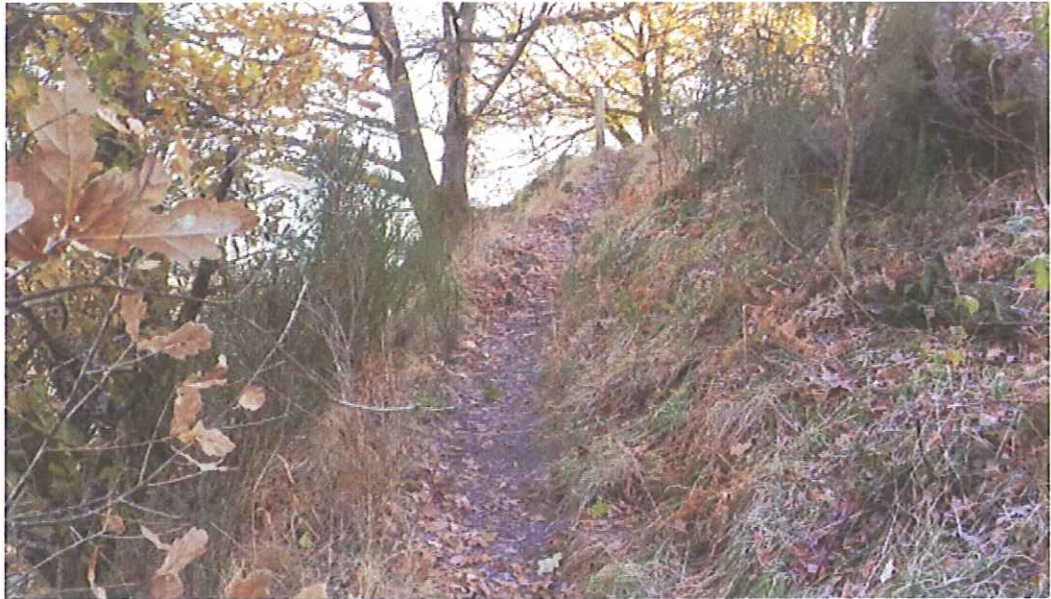
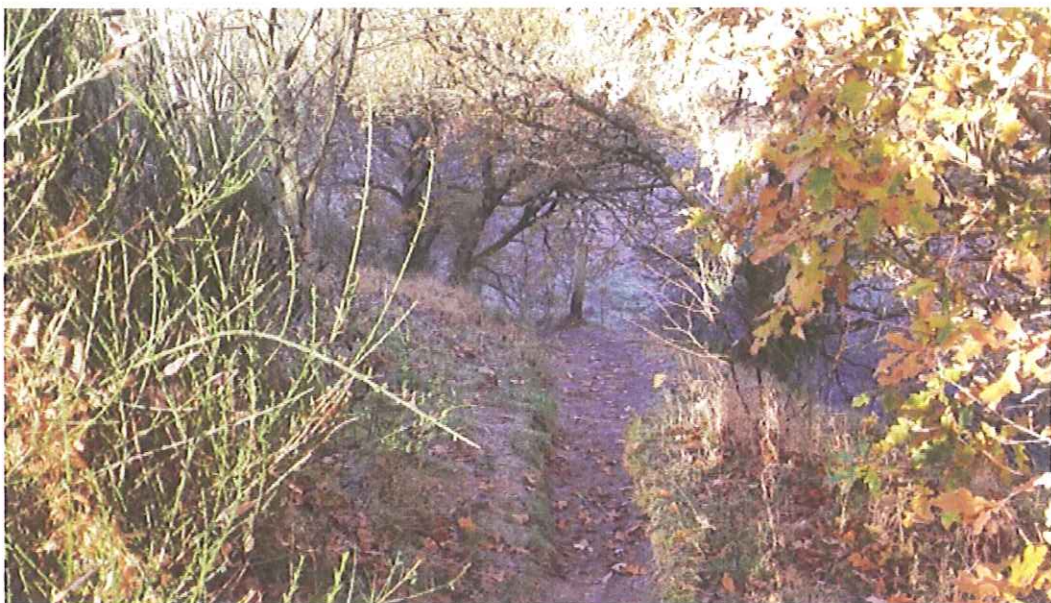
3.5.3 There does not appear to be a route to take any further going along the river bank. The area is overgrown and steeply sloping. The only exit is a path that climbs uphill becoming steep and very narrow, posing a high health and safety risk.

The narrowest part is around a tight bend on the edge of the hill, with a very steep drop off the side, the path is nothing more than a worn track.

- In its current state we would not encourage use of this route, the path is dangerous and should be closed
- Widen the path going uphill at the bend by benching further into the hillside to move the path a safer distance from the edge of the slope.
- Erect a fence to prevent falls over the edge
- A retaining wall will be required for the benching of the path

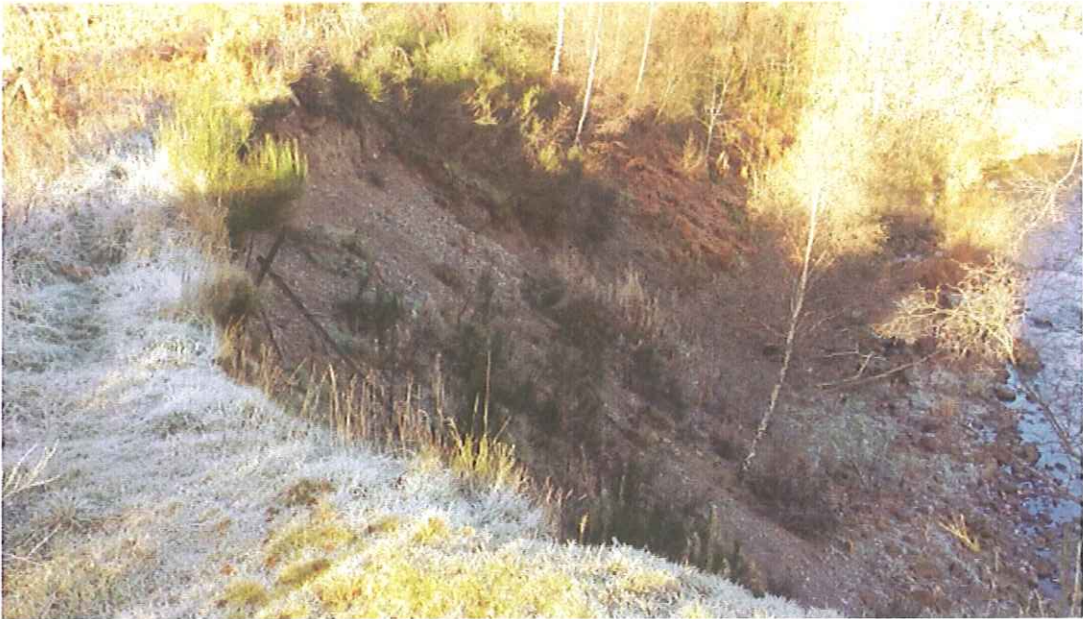
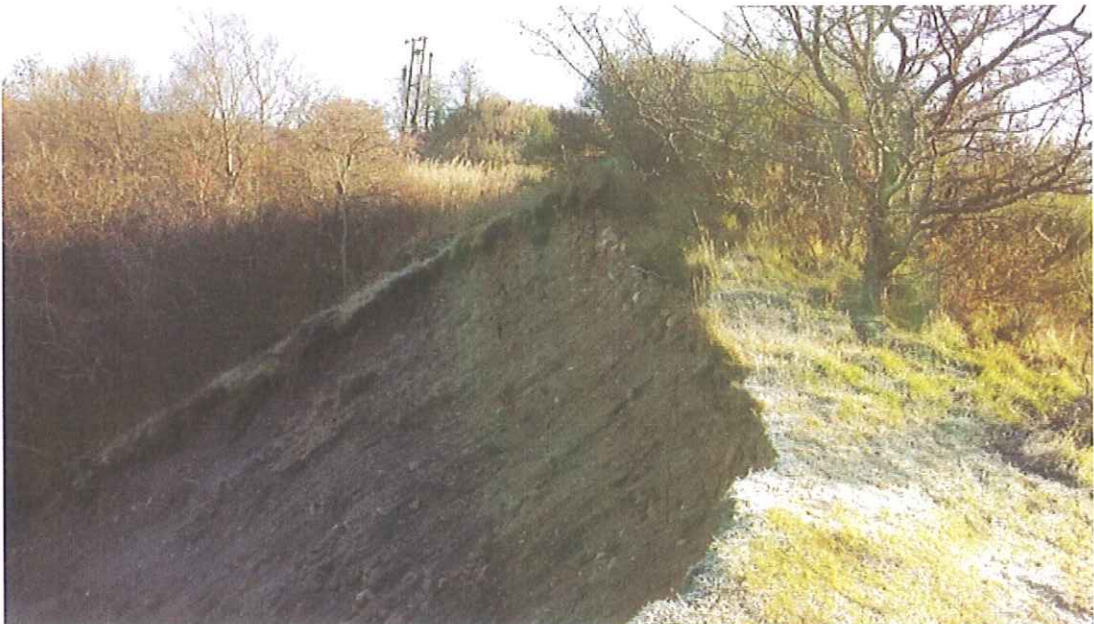
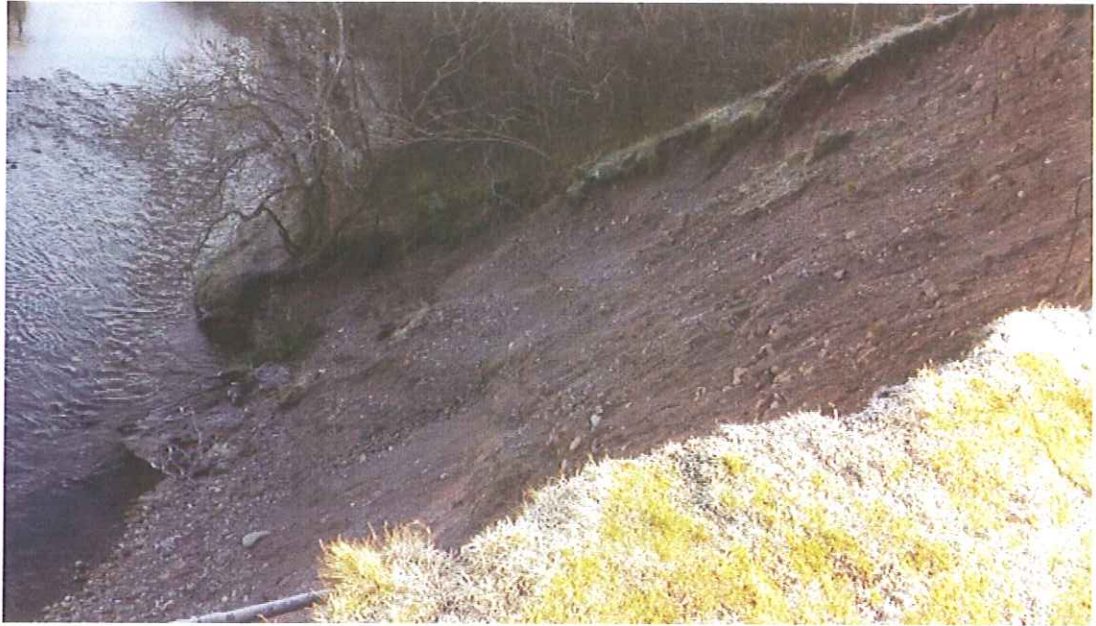
The path passes by a very steep bank down to the river. Major erosion has caused the topsoil to slip from the slope exposing loose sands and gravels. The slope falls directly to the river with no river bank remaining. Further erosion is highly likely. Any preventative measures will be costly and practically difficult. The erosion is starting to create a dangerous overhang. The path itself is set back from the eroded edge a safe distance in its current state. There is evidence that there was fencing along the edge before the landslip.

- We would not encourage the use of this path, new fencing should be erected to close this area off given the extent of erosion and landslip that has occurred. An alternative route is easily available through the flat area. A new route shall also remove the steep section to the high point.
- Any remedial work will require extensive engineering investigation. The solutions will be costly given the extent of the problem

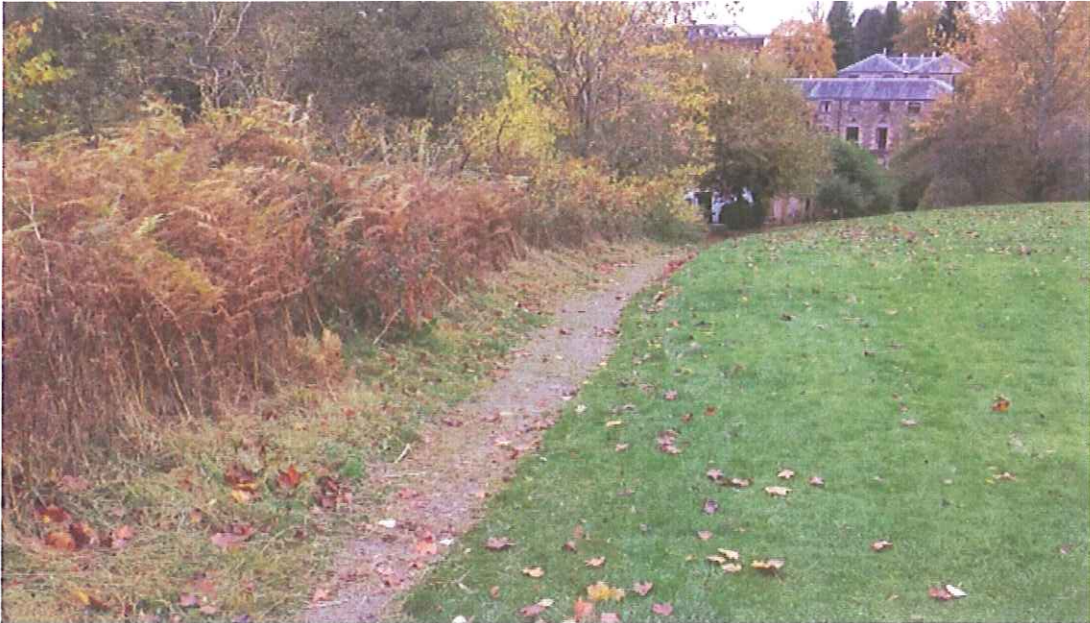
3.7.1 This path links the main access road by foot to the footbridge over the rail line further to the North. This section appears to be formally constructed, being even and solid in appearance. The path is narrow which may have happened over time. As with other pathways, it acts as a water channel down to the main access due to lack of offlet drainage and dished profile. It also collects run-off from the play park area, rather than letting it flow down the adjacent slope to the burn. This path seems well used.

Photograph 42 – looking back towards Allan Water

- Lay timber edging and infill with type 1 sub base material, raising level to remove the dished profile, finish with gravel or whin dust.
- Alternatively construct a formal footpath in bituminous material with precast concrete edging kerbs
- Create offlet drainage to the adjacent slope
- Little excavation required
- Increase width of path to 1.8m
