LAIGHILLS PARK INSPECTION

DOC REF: 12770/DK/198 REVISION A

CLIENT: Stirling council

ENGINEER: Millard Consulting
Seabraes
18 Greenmarket
Dundee
DD1 4QB

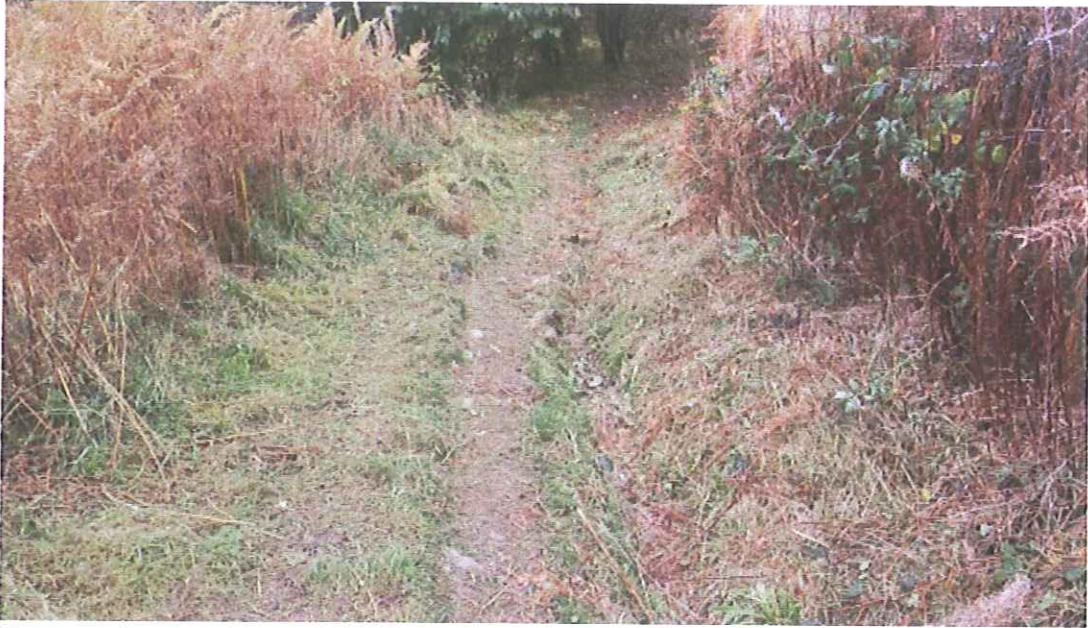
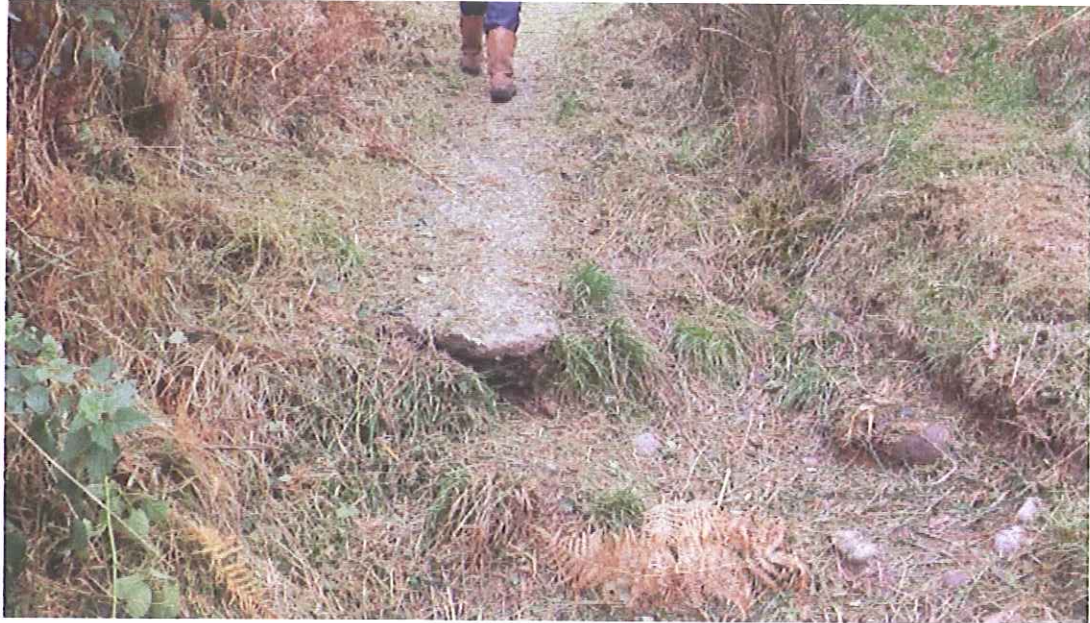
3.8.1 As the path heads north, leaving the play park area it becomes a more informal and well worn countryside path/track. There is a section heading north to the footbridge on a steep incline that has been eroded by surface water. The remainder of previous attempts at repairs are visible. The damage to the path is a danger to the public.

- The eroded section of path should be up filled with type 1 sub-base material to remove tripping hazards.
- Consideration should be given to the creation of low steps in this area
- Steps could be created using timber edging, timber sleepers for steps and filled with type 1 material
- Drainage offlets should be provided uphill from this area to protect it from further erosion

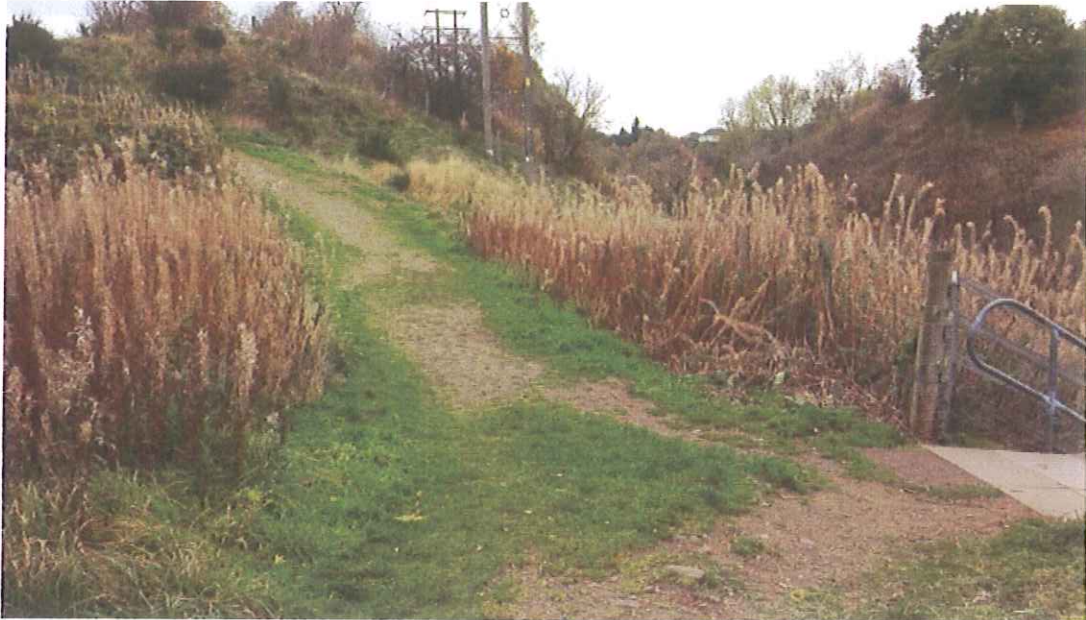
Photograph 45

3.9.1 The area at the top of the access steps to the footbridge is badly worn, albeit not in a dangerous condition. Some boulders protruding from the worn ground could potentially become tripping hazards

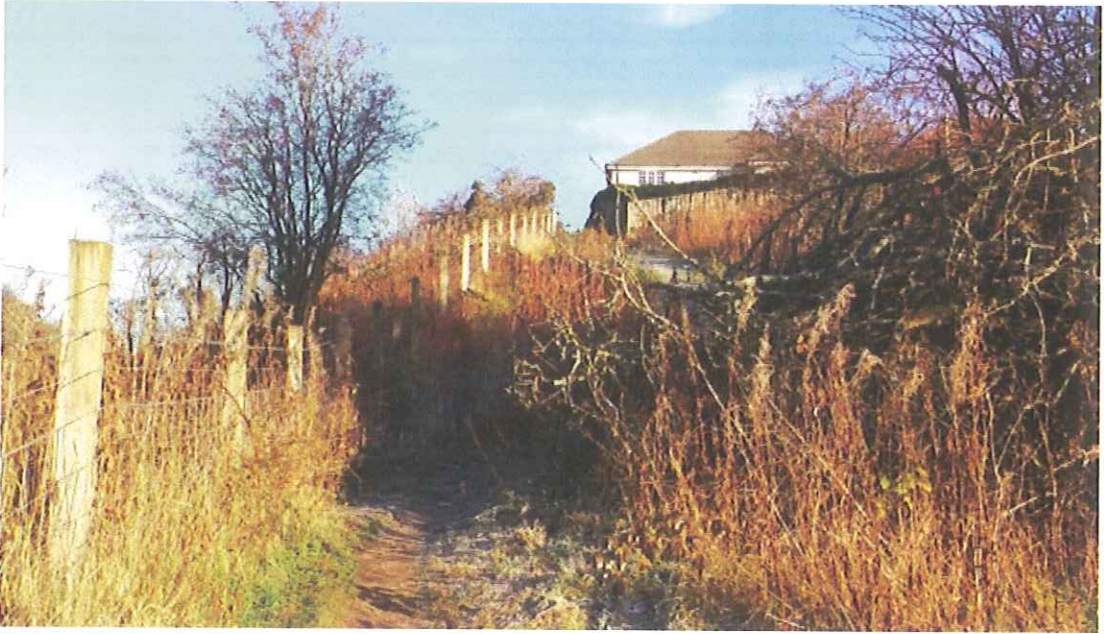
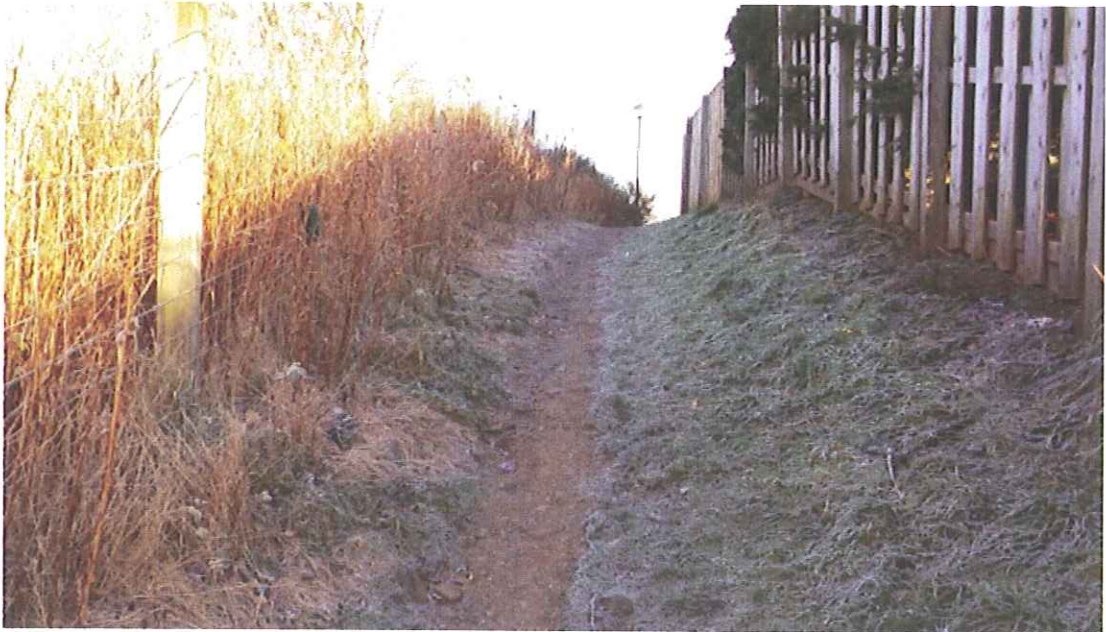
3.11.2 At the slope some informal steps have been created using random flat stones. The actual slope up to the housing estate level is very steep creating a difficult route for pedestrians. The track forms a rutted channel down the slope.

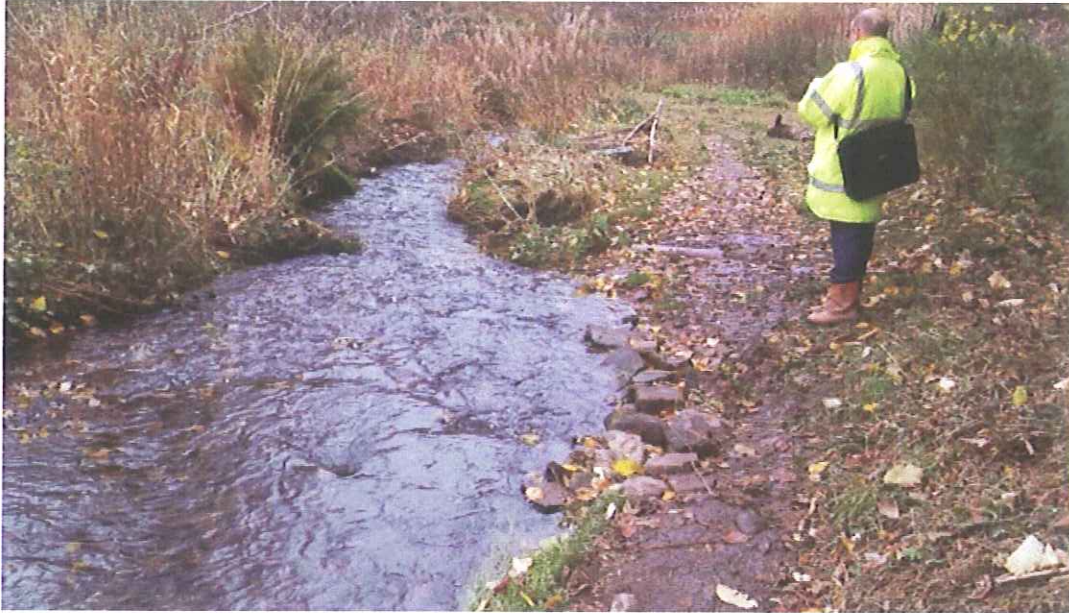
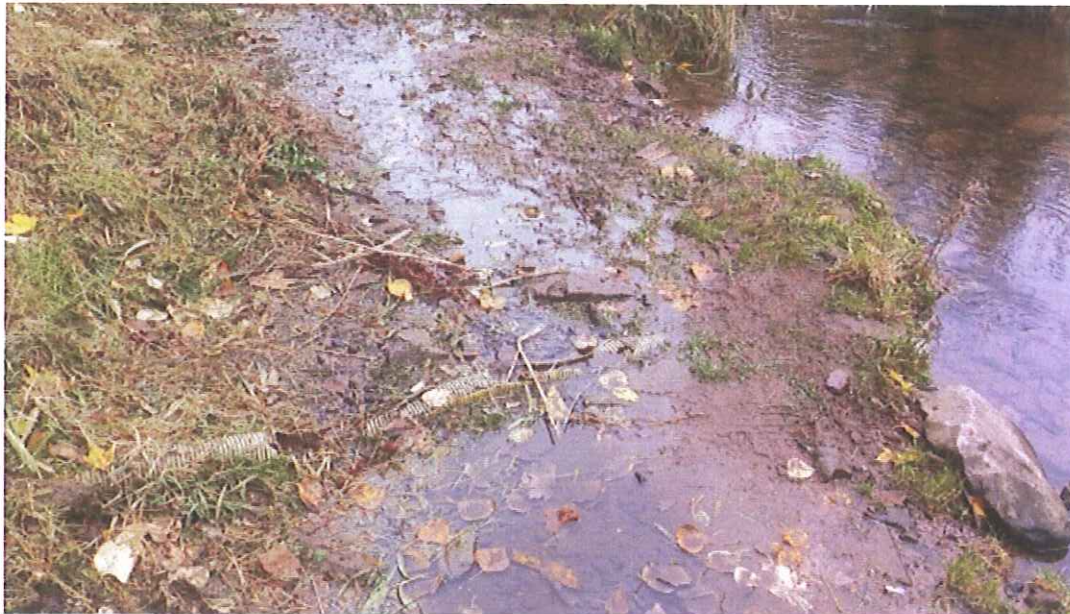
3.13.1 This is a worn pedestrian track heading east along the route of the Scouring Burn. No formal construction has taken place. In some areas the path is very low lying close to the burn, causing flooding issues. Part of the Burn closest to the path has been eroded, creating an overhang that has recently suffered from minor collapse.

- To maintain access to the parks at times of high water level we would recommend raising the level of the paths in the wet areas. The area shown in photographs 59 and 60 is between the north east boundary with the housing estate and the scouring burn. To raise this level some works will be required to the banks of the burn. To minimise groundworks and resultant flooding to other areas, a raised timber deck may be the best solution. This will allow the area to flood below the deck. There is little or no room to divert the path.

- Where the burn is eroding the banks close to the path, a form of protection should be constructed such as gabion baskets. This will also provide stability to the path

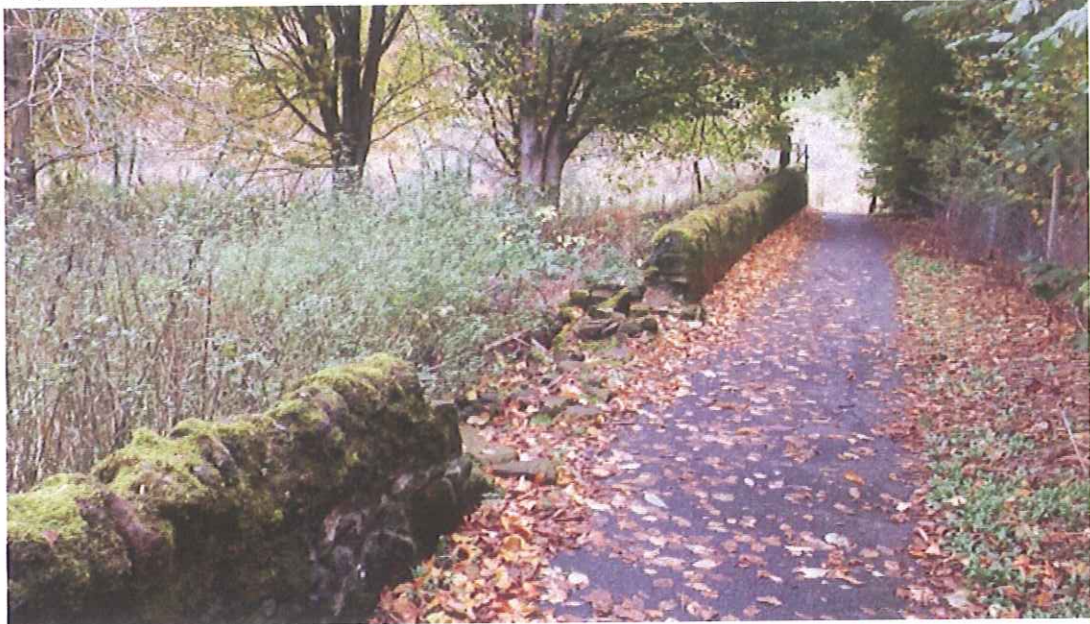
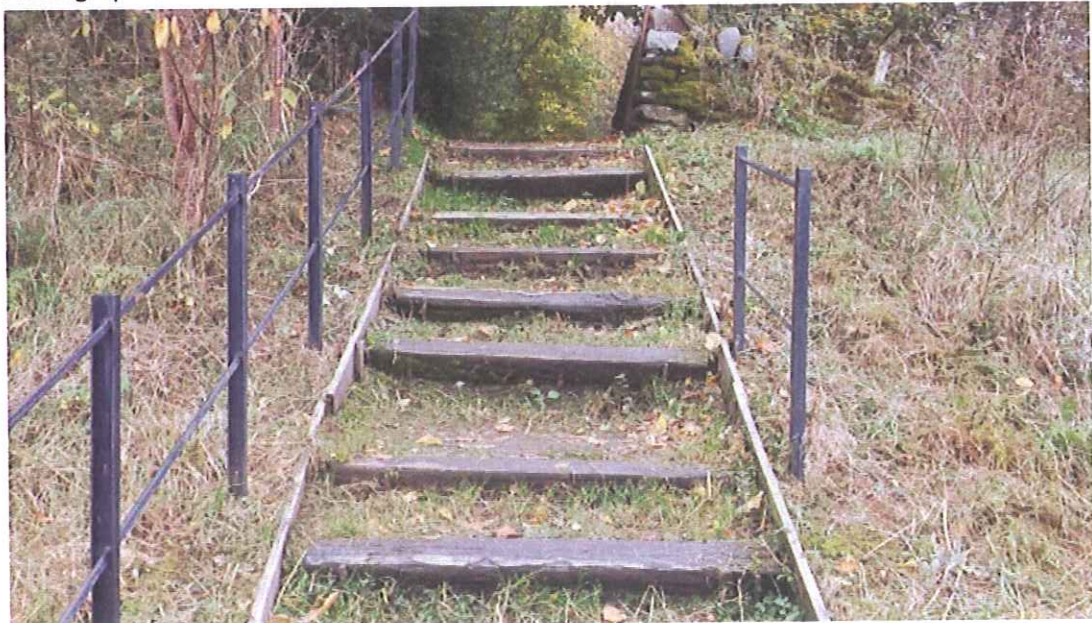
3.14.1 There is a stepped access to the park from Balmyle Grove. The boundary wall en route to the steps has collapsed and requires rebuilding. The steps themselves are in need of refreshing. The steps are slippery in the wet/damp, and are relatively steep. The flat areas require infilled.

- We would recommend complete replacement of the steps and handrails in similar materials. It may be worthwhile reducing the rise of each step to make them safer.

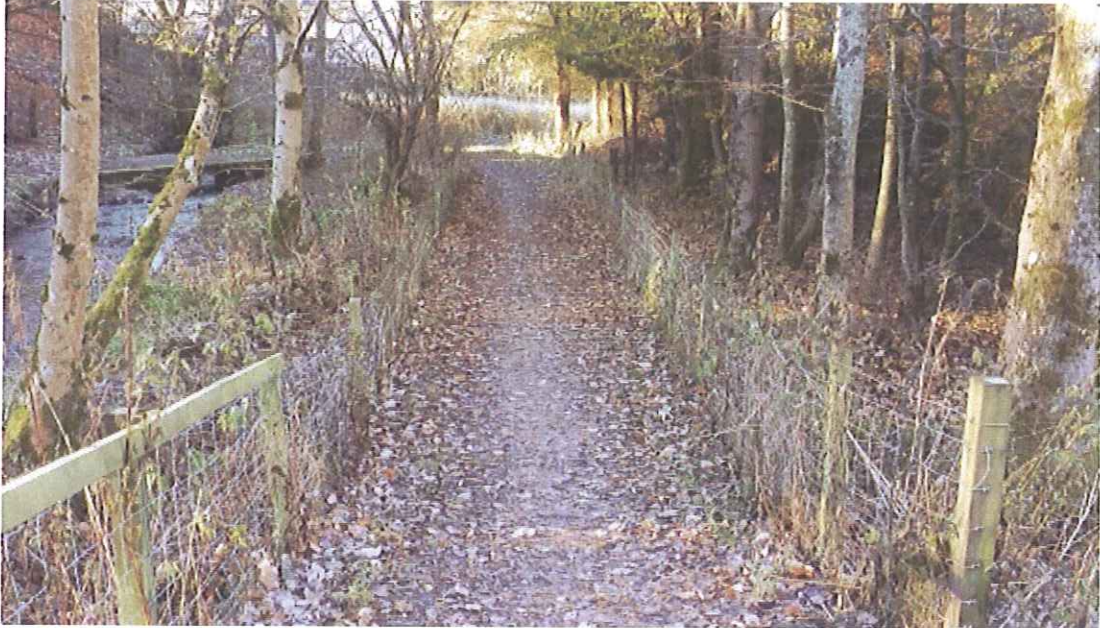
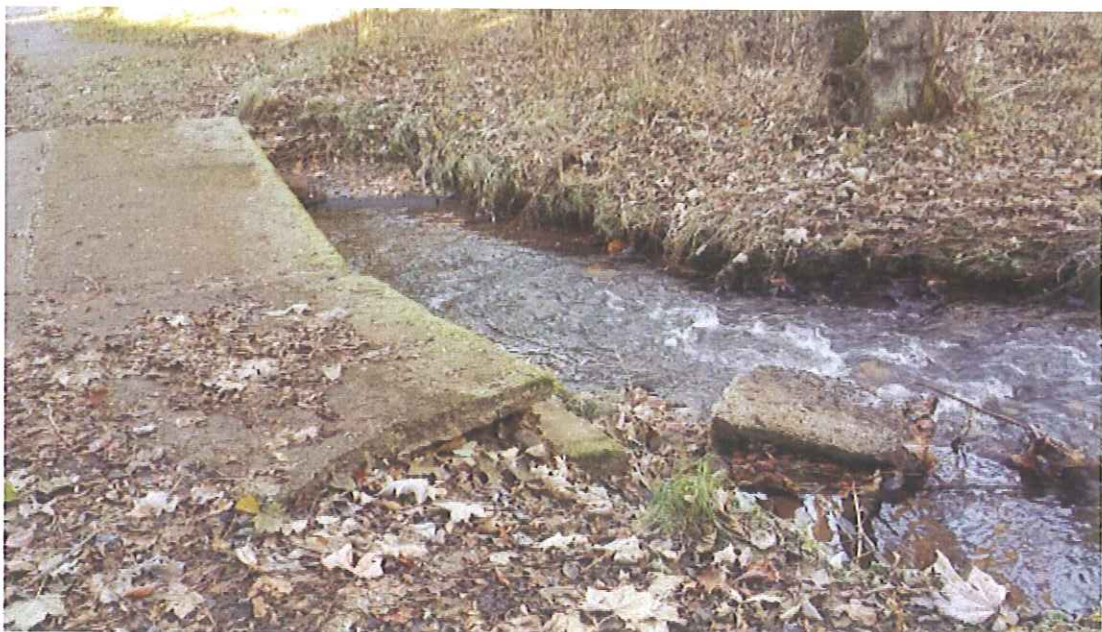
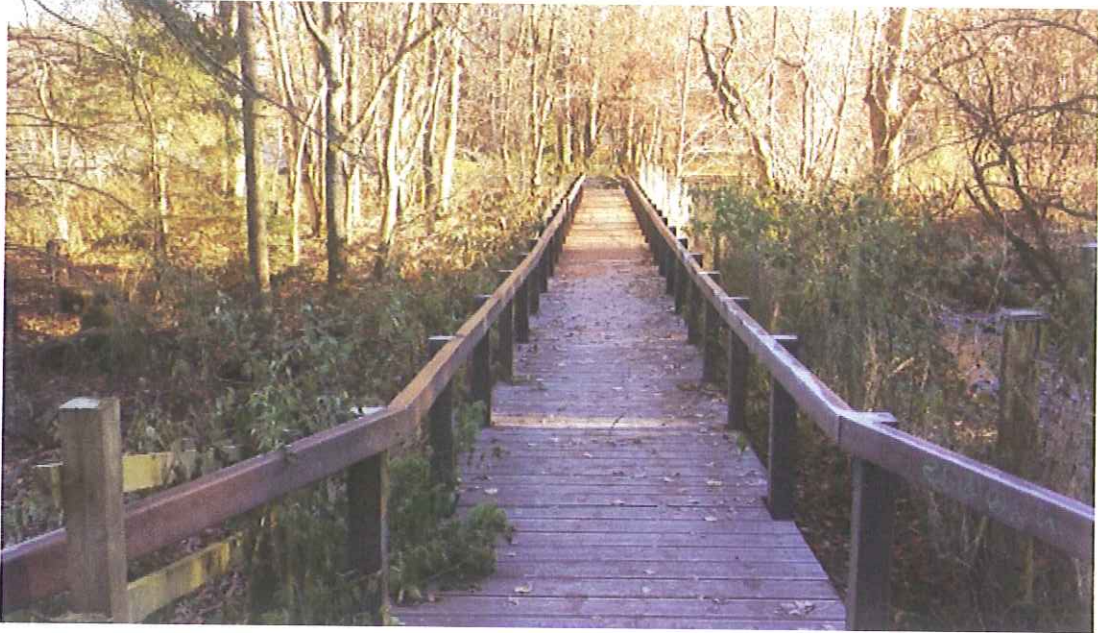
Westwards into the park there is another path to take which crosses an old concrete bridge over the burn. The concrete is in poor condition, broken in places, and scoured at its edges with the path. This path is also of old bituminous construction and joins the track from item 3.13.1. These sections of path are under the tree canopy, and at the time of inspection were covered in leaves. The surfacing looks old but is not in disrepair.

- 19.1 Remove the dilapidated concrete bridge and close the footpath linked to it. Direct users to cross the burn over the new bridge

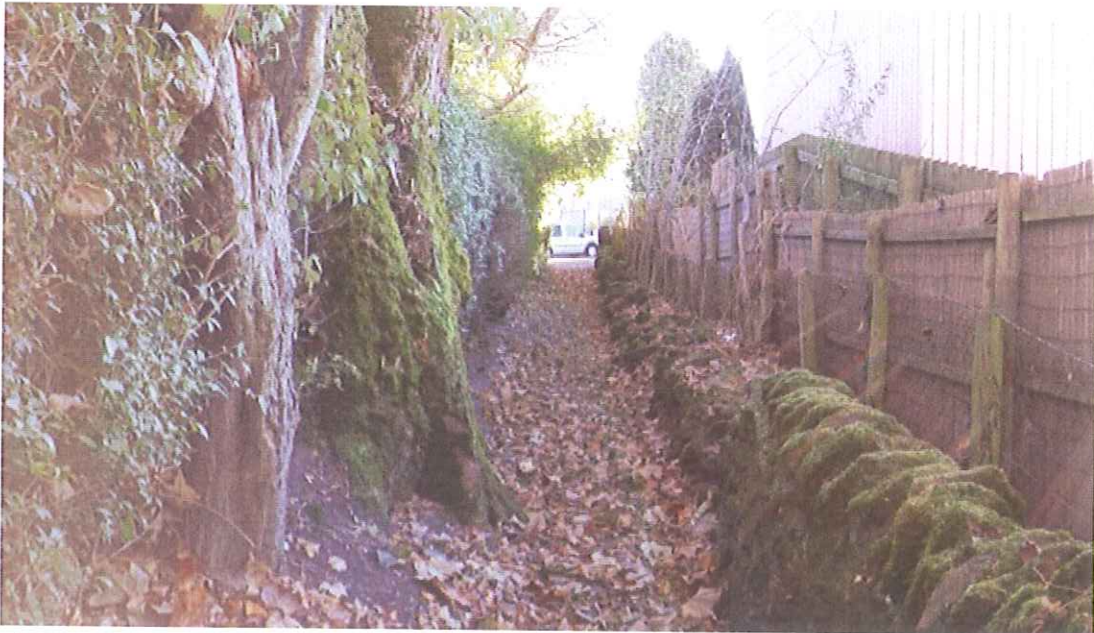
Photograph 68

This access can be classed as in poor condition. The path is very narrow bounded on one side by a low height old stone wall and trees/hedging on the other.

- Infill the path from Ramoyle to the Scouring Burn with gravel, little else can be done in this location due to the close proximity of large trees and hedging. The rough area at the end of the path requires regrading to flatten off the uneven ground.
- The steps require maintenance, primarily to fill in the worn areas between the timber steps. May be beneficial at this time to replace the timber steps
- The concrete bridge requires replacement, including landing areas.

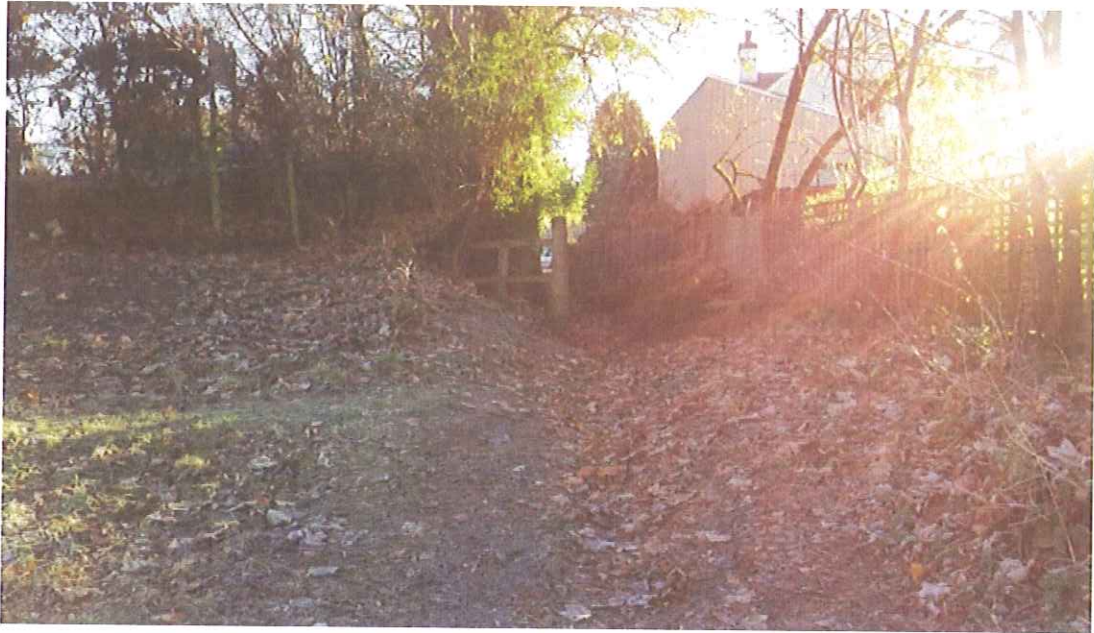
Photograph 69

The path is of bituminous construction, but in very poor condition. It is a very dark and damp route into the park. At the time of inspection the path was thick with fallen leaves. The path leads to the corridor of the Scouring Burn opening into an area of very rough uneven ground.

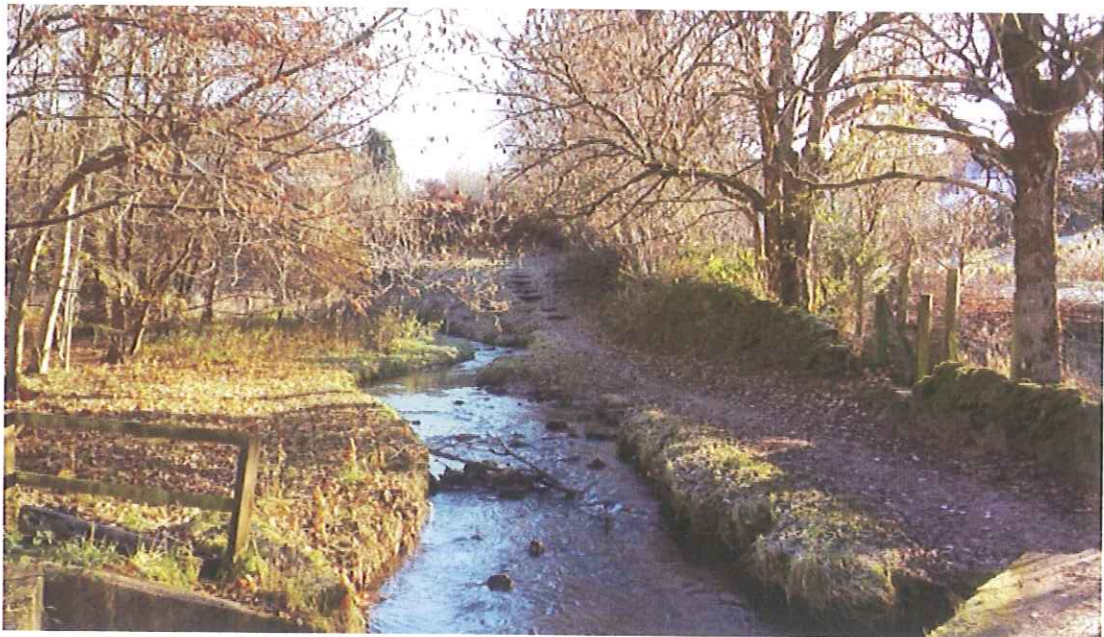
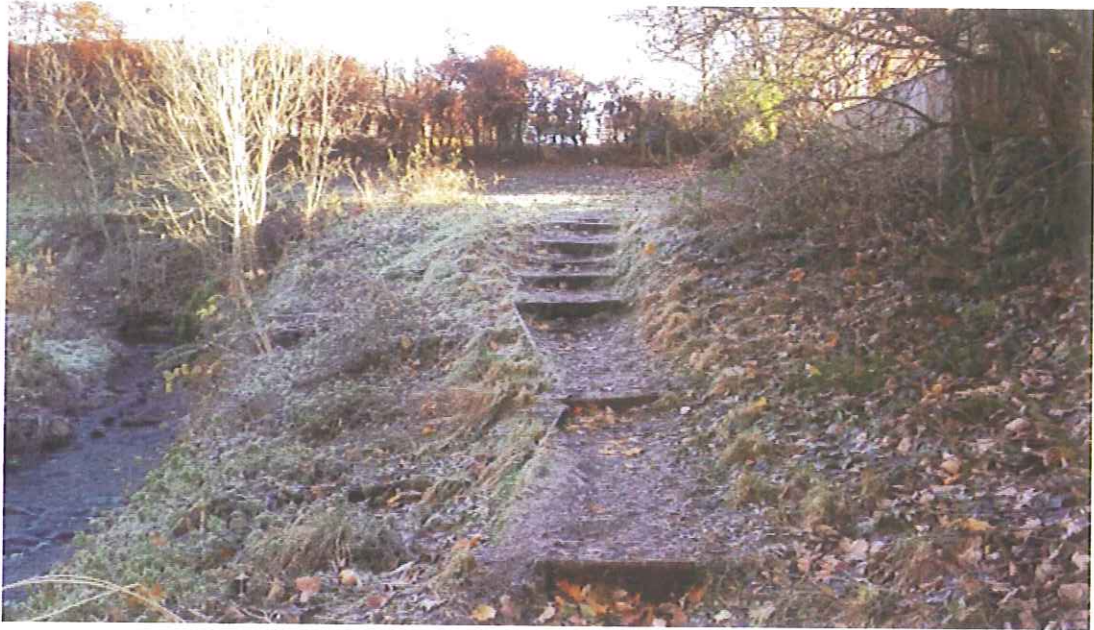
Steps give access to the lower level path by the burn which is generally smooth and flat. The steps themselves are in poor condition and require replacement.

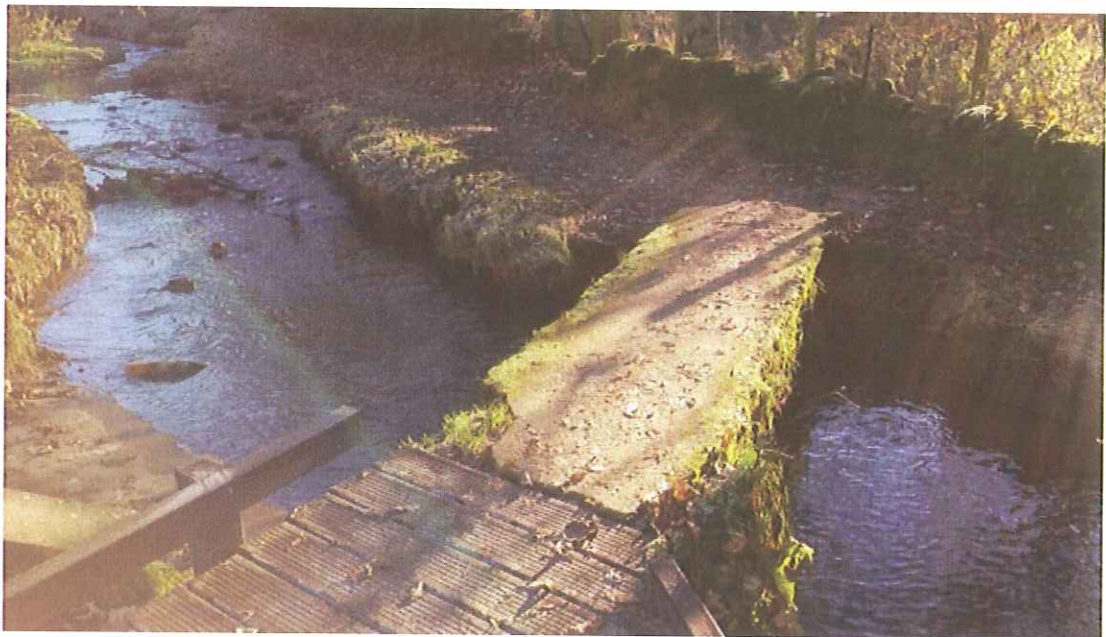
Photograph 72

In order to cross the burn and join the raised timber deck in item 19.1 users must cross a narrow dilapidated concrete bridge. The bridge is in poor condition and requires replacement.
