TD TREE & LAND SERVICES LTD

Visual Tree Assessment (Type 1) Arboricultural Hazard and Risk Report Woodland Management Strategy

Client: Holmehill Ltd
24 Dargai Terrace
Dunblane
FK15 0AU

Site: Holme Hill Community Woodland
Dunblane
Stirlingshire

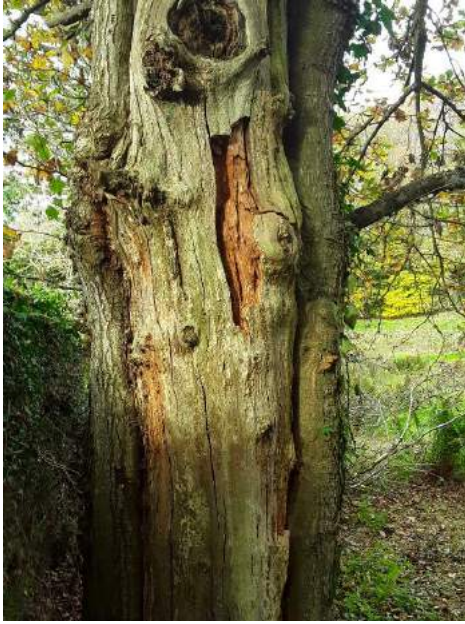
MapNo: 1120 KTId: 110094309
Date: 2018-10-25
ExtId: 1120

No	Species	Height (m)	Age Class	Next Inspection	Priority	Est. Duration
1120	Quercus robur (English Oak)	17	EarlyMature	25-10-2019	3	3
	GENERAL OBSERVATIONS Large collum of Hart wood decay from ground level to 4m. Some reaction wood forming. CATEGORY C; PHYSICAL_CONDITION Fair; STRUCTURAL_CONDITION Poor; LIFE EXPECTANCY <10 years; TREE/GROUP TAG 1120; KT ASSET ID 110094309; INSPECTION TYPE Cyclical; TRAFFIC MANAGEMENT REQD None; NUMBER OF STEMS 1; RPA 191m ² ; RPA RADIUS 7.8m; CANOPY SPREAD N 3m, E 3m, S 2m, W 4m; AMENITY VALUE Medium; EASTING/NORTHING point(278276.93 701455.15); USER NAME TD Trees		PRELIMINARY RECOMMENDATIONS Fell Tree ; Plant / Replant Tree			
1130	Fagus sylvatica (Common Beech)	19	Mature	25-10-2019	2	6
	GENERAL OBSERVATIONS Tree has experanced huge historic wind loading resulting in a dramatic northward lean. Large decay hollow in lower bole from 2m to 10m. New vertical cracking showing from 2m to 6m on western aspect of bole. CATEGORY U; PHYSICAL_CONDITION Fair; STRUCTURAL_CONDITION Poor; LIFE EXPECTANCY <10 years; TREE/GROUP TAG 1130; KT ASSET ID 110094301; INSPECTION TYPE Cyclical; TRAFFIC MANAGEMENT REQD None; NUMBER OF STEMS 1; RPA 327m ² ; RPA RADIUS 10.2m; CANOPY SPREAD N 9m, E 4m, S 2m, W 5m; AMENITY VALUE Medium; EASTING/NORTHING point(278339.33 701450.16); USER NAME TD Trees		PRELIMINARY RECOMMENDATIONS Fell Tree ; Plant / Replant Tree

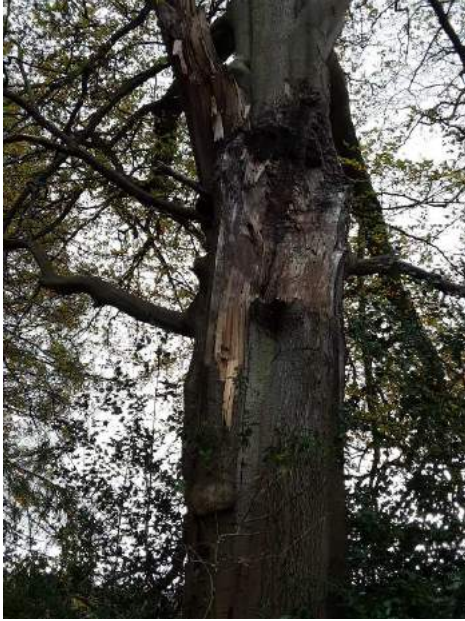
MapNo: 1131 KTId: 110094300
Date: 2018-10-25
ExtId: 1131

1131	Fagus sylvatica (Common Beech)	22	Mature	25-10-2019	3	4
	GENERAL OBSERVATIONS Large boundary tree on exposed hillside. Very largd historical tear out at 6m north. Resulting in a large wound and loss of structural integrity. Unbalanced canopy. Client particularly interested in preserving tree if possible. CATEGORY C; PHYSICAL_CONDITION Fair; STRUCTURAL_CONDITION Poor; LIFE EXPECTANCY 10-19 years; TREE/GROUP TAG 1131; KT ASSET ID 110094300; INSPECTION TYPE Cyclical; TRAFFIC MANAGEMENT REQD None; NUMBER OF STEMS 1; RPA 707m ² ; RPA RADIUS 15.0m; CANOPY SPREAD N 4m, E 8m, S 8m, W 5m; AMENITY VALUE Medium; EASTING/NORTHING point(278345.12 701443.90); USER NAME TD Trees		PRELIMINARY RECOMMENDATIONS Remove Deadwood: Major ; Areal inspection required. If inspection allows retention of tree. Rebalance crown and reduce by 20% to protect against further failure.			
1139	Fagus sylvatica (Common Beech)	19	Mature	25-10-2019	3	4

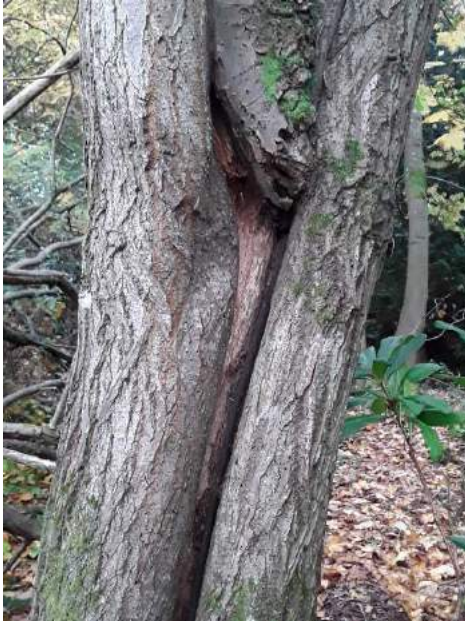
MapNo: 1158 KTIId: 110094283
Date: 2018-10-25
ExtId: 1158

1158	Salix caprea (Goat Willow)	14	SemiMature	25-10-2019	2	2
	GENERAL OBSERVATIONS Large inclusion from ground level, Hart wood decay. Partly failed crown resting in adjacent tree. CATEGORY C; PHYSICAL_CONDITION Poor; STRUCTURAL_CONDITION Poor; LIFE EXPECTANCY <10 years; TREE/GROUP TAG 1158; KT ASSET ID 110094283; INSPECTION TYPE Cyclical; TRAFFIC MANAGEMENT REQD None; NUMBER OF STEMS 1; RPA 55m ² ; RPA RADIUS 4.2m; CANOPY SPREAD N 2m, E 3m, S 2m, W 2m; AMENITY VALUE Low; EASTING/NORTHING point(278510.31 701492.14); USER NAME TD Trees		PRELIMINARY RECOMMENDATIONS Fell Tree ; Plant / Replant Tree			
1159	Salix caprea (Goat Willow)	4	SemiMature	25-10-2019	3	1
	GENERAL OBSERVATIONS Failed main stem. Crown resting on ground. CATEGORY U; PHYSICAL_CONDITION Dead; STRUCTURAL_CONDITION Dead; LIFE EXPECTANCY <10 years; TREE/GROUP TAG 1159; KT ASSET ID 110094284; INSPECTION TYPE Cyclical; TRAFFIC MANAGEMENT REQD None; NUMBER OF STEMS 1; RPA 41m ² ; RPA RADIUS 3.6m; AMENITY VALUE Low; EASTING/NORTHING point(278505.51 701490.38); USER NAME TD Trees		PRELIMINARY RECOMMENDATIONS Fell Tree ; Plant / Replant Tree ;

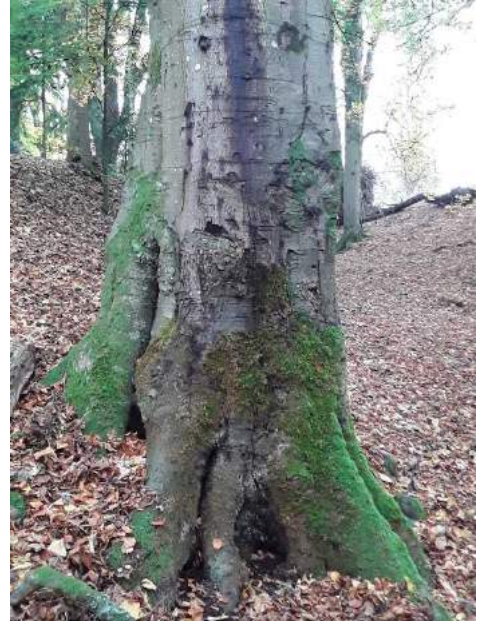
MapNo: 1160 KTIId: 110094285
Date: 2018-10-25
ExtId: 1160

1160	Fagus sylvatica (Common Beech)	25	Mature	29-10-2019	3	4
	GENERAL OBSERVATIONS Large tree on side of main public access road. Large buttress on all sides. Parcel degradation of cambium on lower bole. Kretchmeria deausta from base to 3m on southern aspect. Resent limb loss in upper canopy, hanging dead wood in crown. Dead wood over track. CATEGORY B; PHYSICAL_CONDITION Fair; STRUCTURAL_CONDITION Fair; LIFE EXPECTANCY <10 years; TREE/GROUP TAG 1160; KT ASSET ID 110094285; INSPECTION TYPE Cyclical; TRAFFIC MANAGEMENT REQD None; NUMBER OF STEMS 1; RPA 707m ² ; RPA RADIUS 15.0m; CANOPY SPREAD N 8m, E 8m, S 8m, W 8m; AMENITY VALUE Medium; EASTING/NORTHING point(278472.83 701522.60); USER NAME TD Trees		PRELIMINARY RECOMMENDATIONS Remove Deadwood: Moderate ; Thin Crown: Moderate ; Monitor yearly for any further reduction in crown vigour.			
1161	Tilia x europaea (Common Lime) (group)	19	Mature	25-10-2019	4	3

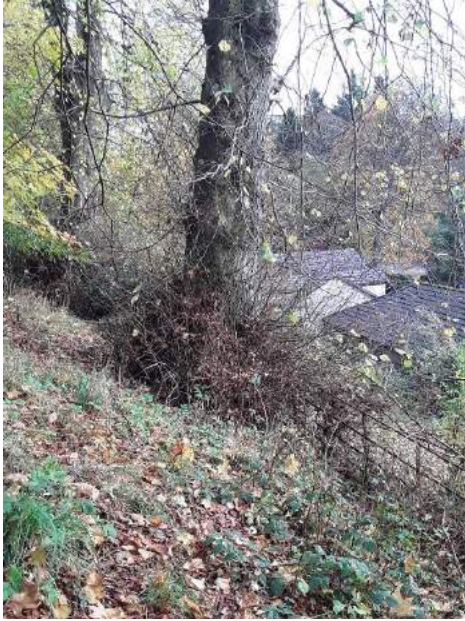
MapNo: 1161 KTIId: 110094286
Date: 2018-10-25
ExtId: 1161

TREE/GROUP TAG 1161; KT ASSET ID 110094286; INSPECTION TYPE Cyclical; TRAFFIC MANAGEMENT REQD None; EST. NUMBER OF TREES 5 SPECIES Tilia x europaea (Common Lime) 100%; PHYSICAL CONDITION Fair; STRUCTURAL CONDITION Fair; AGE CLASS Mature; GENERAL OBSERVATIONS Large boundary trees with houses within target distance. Large amount of basel growth preventing full inspection of trees. ; EASTING/NORTHING point(278466.04 701459.97); USER NAME TD Trees		PRELIMINARY RECOMMENDATIONS Remove Basal Suckers (5 of group) ; Remove basal growth to allow yearly inspection. (5 of group)			
1162	Picea abies (Norway spruce)	15	SemiMature	25-10-2019	3	2
	GENERAL OBSERVATIONS Failed tree now resting in adjacent tree. CATEGORY U; PHYSICAL_CONDITION Dead; STRUCTURAL_CONDITION Dead; LIFE EXPECTANCY <10 years; TREE/GROUP TAG 1162; KT ASSET ID 110094287; INSPECTION TYPE Cyclical; TRAFFIC MANAGEMENT REQD None; NUMBER OF STEMS 1; RPA 28m ² ; RPA RADIUS 3.0m; AMENITY VALUE Low; EASTING/NORTHING point(278474.38 701486.21); USER NAME TD Trees		PRELIMINARY RECOMMENDATIONS Fell Tree ; Plant / Replant Tree

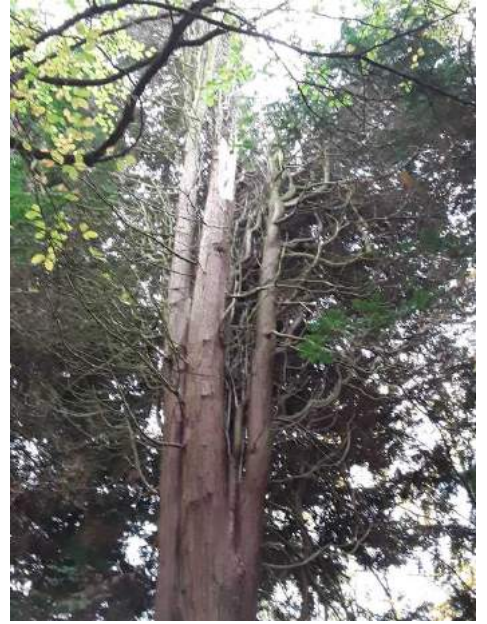
MapNo: 1165 KTId: 110094290
Date: 2018-10-25
ExtId: 1165

1165	Cupressus x leylandii (Leyland Cypress)	17	Mature	25-10-2019	3	4
	GENERAL OBSERVATIONS Two seactions of the eastern crown have recently failed. Leaving the crown very unbalanced. Large wounds now presant in upper crown. CATEGORY C; PHYSICAL_CONDITION Fair; STRUCTURAL_CONDITION Poor; LIFE EXPECTANCY <10 years; TREE/GROUP TAG 1165; KT ASSET ID 110094290; INSPECTION TYPE Cyclical; TRAFFIC MANAGEMENT REQD None; NUMBER OF STEMS 1; RPA 222m ² ; RPA RADIUS 8.4m; CANOPY SPREAD N 3m, E 1m, S 4m, W 4m; AMENITY VALUE Low; EASTING/NORTHING point(278428.31 701505.95); USER NAME TD Trees					PRELIMINARY RECOMMENDATIONS Fell Tree ; Plant / Replant Tree ; Replant with native spices.
1166	Chamaecyparis lawsoniana (Lawson's Cypress)	18	Mature	25-10-2019	3	3
	GENERAL OBSERVATIONS Loss of eastern canopy has lead to dramatically reduced structural integrity of the remaining canopy. CATEGORY C; PHYSICAL_CONDITION Fair; STRUCTURAL_CONDITION Poor; LIFE EXPECTANCY <10 years; TREE/GROUP TAG 1166; KT ASSET ID 110094291; INSPECTION TYPE Cyclical; TRAFFIC MANAGEMENT REQD None; NUMBER OF STEMS 1; RPA 209m ² ; RPA RADIUS 8.2m; CANOPY SPREAD N 1m, E 0m, S 1m, W 3m; AMENITY VALUE Low; EASTING/NORTHING point(278407.33 701520.10); USER NAME TD Trees					PRELIMINARY RECOMMENDATIONS Fell Tree ; Plant / Replant Tree

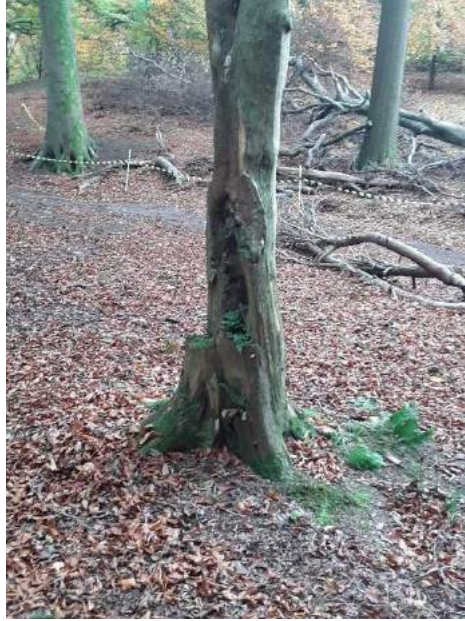
MapNo: 1167 KTId: 110094292
Date: 2018-10-25
ExtId: 1167

1167	Cupressus spp (Cypress species)	10	EarlyMature	25-10-2019	4	1
	GENERAL OBSERVATIONS Almost no crown vigour. CATEGORY C; PHYSICAL_CONDITION Poor; STRUCTURAL_CONDITION Poor; LIFE EXPECTANCY <10 years; TREE/GROUP TAG 1167; KT ASSET ID 110094292; INSPECTION TYPE Cyclical; TRAFFIC MANAGEMENT REQD None; NUMBER OF STEMS 1; RPA 55m ² ; RPA RADIUS 4.2m; AMENITY VALUE Low; EASTING/NORTHING point(278402.53 701520.22); USER NAME TD Trees					PRELIMINARY RECOMMENDATIONS Fell Tree ; Plant / Replant Tree
1168	Acer pseudoplatanus (Sycamore)	24	Mature	25-10-2019	2	2
	GENERAL OBSERVATIONS Large multi stemmed tree with well occluded unions. Large diameter dead wood over main public access track. CATEGORY B; PHYSICAL_CONDITION Fair; STRUCTURAL_CONDITION Fair; LIFE EXPECTANCY >40 years; TREE/GROUP TAG 1168; KT ASSET ID 110094293; INSPECTION TYPE Cyclical; TRAFFIC MANAGEMENT REQD None; NUMBER OF STEMS 1; RPA 707m ² ; RPA RADIUS 15.0m; CANOPY SPREAD N 4m, E 4m, S 7m, W 7m; AMENITY VALUE Medium; EASTING/NORTHING point(278406.38 701532.01); USER NAME TD Trees					PRELIMINARY RECOMMENDATIONS Remove Deadwood: Major

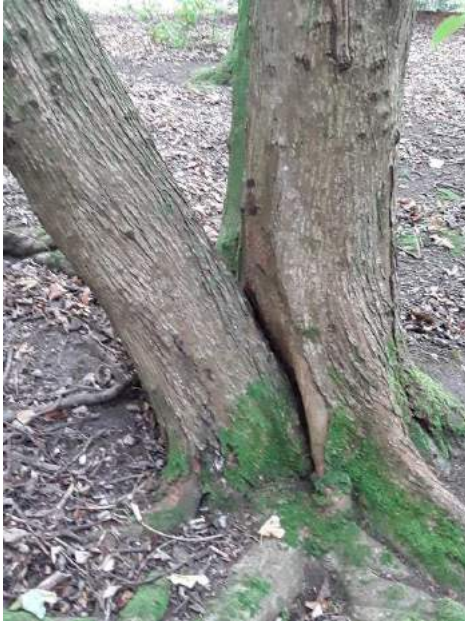
MapNo: 1169 KTIId: 110094294
Date: 2018-10-25
ExtId: 1169

1169	Ulmus glabra (Wych Elm)	15	EarlyMature	25-10-2019	3	2
	GENERAL OBSERVATIONS Poorly included union at base has failed leaving eastern stem hanging in adjacent tree. CATEGORY C; PHYSICAL_CONDITION Fair; STRUCTURAL_CONDITION Poor; LIFE EXPECTANCY 10-19 years; TREE/GROUP TAG 1169; KT ASSET ID 110094294; INSPECTION TYPE Cyclical; TRAFFIC MANAGEMENT REQD None; NUMBER OF STEMS 3; RPA 132m ² ; RPA RADIUS 6.5m; CANOPY SPREAD N 3m, E 4m, S 3m, W 2m; AMENITY VALUE Low; EASTING/NORTHING point(278390.21 701506.46); USER NAME TD Trees					PRELIMINARY RECOMMENDATIONS Remove eastern stem from adjacent tree.
1170	Salix caprea (Goat Willow)	10	SemiMature	25-10-2019	4	1
	GENERAL OBSERVATIONS Windblown tree lying on adjacent yew. CATEGORY C; PHYSICAL_CONDITION Fair; STRUCTURAL_CONDITION Poor; LIFE EXPECTANCY <10 years; TREE/GROUP TAG 1170; KT ASSET ID 110094295; INSPECTION TYPE Cyclical; TRAFFIC MANAGEMENT REQD None; NUMBER OF STEMS 1; RPA 13m ² ; RPA RADIUS 2.0m; CANOPY SPREAD N 2m, E 2m, S 2m, W 2m; AMENITY VALUE Low; EASTING/NORTHING point(278449.23 701484.44); USER NAME TD Trees					PRELIMINARY RECOMMENDATIONS Fell Tree ; Plant / Replant Tree

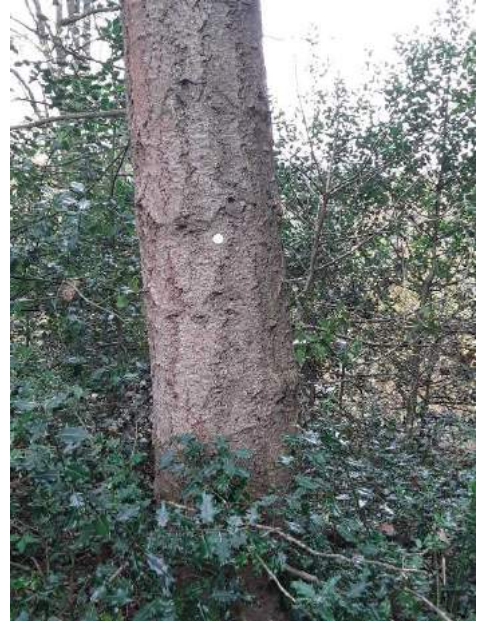
MapNo: 1171 KTIId: 110094296
Date: 2018-10-25
ExtId: 1171

1171	Picea abies (Norway spruce)	17	Mature	25-10-2019	4	3
	GENERAL OBSERVATIONS Complete loss of upper crown. Reduced canopy vigor throughout tree. CATEGORY C; PHYSICAL_CONDITION Poor; STRUCTURAL_CONDITION Poor; LIFE EXPECTANCY <10 years; TREE/GROUP TAG 1171; KT ASSET ID 110094296; INSPECTION TYPE Cyclical; TRAFFIC MANAGEMENT REQD None; NUMBER OF STEMS 1; RPA 113m ² ; RPA RADIUS 6.0m; CANOPY SPREAD N 1m, E 1m, S 1m, W 1m; AMENITY VALUE Low; EASTING/NORTHING point(278451.69 701476.32); USER NAME TD Trees					PRELIMINARY RECOMMENDATIONS Fell Tree ; Plant / Replant Tree
1172	Ilex aquifolium (Holly)	8	EarlyMature	25-10-2019	3	1
	GENERAL OBSERVATIONS CATEGORY C; PHYSICAL_CONDITION Dead; STRUCTURAL_CONDITION Dead; LIFE EXPECTANCY <10 years; TREE/GROUP TAG 1172; KT ASSET ID 110094297; INSPECTION TYPE Cyclical; TRAFFIC MANAGEMENT REQD None; NUMBER OF STEMS 1; RPA 72m ² ; RPA RADIUS 4.8m; AMENITY VALUE Low; EASTING/NORTHING point(278444.87 701455.25); USER NAME TD Trees					PRELIMINARY RECOMMENDATIONS Fell Tree ; Plant / Replant Tree

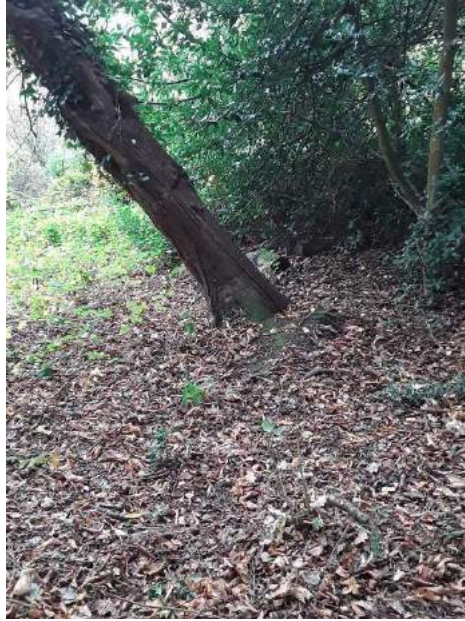
MapNo: 1173 KTIId: 110094298
Date: 2018-10-25
ExtId: 1173

1173	Cupressus x leylandii (Leyland Cypress)	18	EarlyMature	25-10-2019	2	3
	GENERAL OBSERVATIONS Tree has significant lean towards residential area. Evidence of root plate movement at base. CATEGORY U; PHYSICAL_CONDITION Fair; STRUCTURAL_CONDITION Poor; LIFE EXPECTANCY <10 years; TREE/GROUP TAG 1173; KT ASSET ID 110094298; INSPECTION TYPE Cyclical; TRAFFIC MANAGEMENT REQD None; NUMBER OF STEMS 1; RPA 76m ² ; RPA RADIUS 4.9m; CANOPY SPREAD N 2m, E 2m, S 2m, W 2m; AMENITY VALUE Low; EASTING/NORTHING point(278416.00 701413.69); USER NAME TD Trees					PRELIMINARY RECOMMENDATIONS Fell Tree ; Plant / Replant Tree

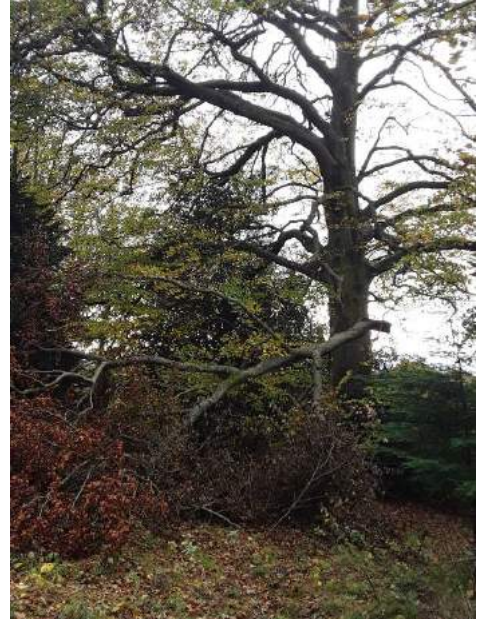
MapNo: 1174 KTIId: 110094302
Date: 2018-10-25
ExtId: 1174

No	Species	Height (m)	Age Class	Next Inspection	Priority	Est. Duration
1174	Fagus sylvatica (Common Beech)	20	Mature	25-10-2019	2	2
	GENERAL OBSERVATIONS Several failed hanging sections of canopy require removal. CATEGORY B; PHYSICAL_CONDITION Fair; STRUCTURAL_CONDITION Fair; LIFE EXPECTANCY >40 years; TREE/GROUP TAG 1174; KT ASSET ID 110094302; INSPECTION TYPE Cyclical; TRAFFIC MANAGEMENT REQD None; NUMBER OF STEMS 1; RPA 707m ² ; RPA RADIUS 15.0m; CANOPY SPREAD N 5m, E 5m, S 5m, W 6m; AMENITY VALUE Medium; EASTING/NORTHING point(278374.30 701423.81); USER NAME TD Trees		PRELIMINARY RECOMMENDATIONS Remove all hanging branches.			
1175	Salix caprea (Goat Willow)	17	Mature	25-10-2019	2	1
	GENERAL OBSERVATIONS Dead hanging branches in lower crown. Included union at base. CATEGORY C; PHYSICAL_CONDITION Fair; STRUCTURAL_CONDITION Fair; TREE/GROUP TAG 1175; KT ASSET ID 110094299; INSPECTION TYPE Cyclical; TRAFFIC MANAGEMENT REQD None; NUMBER OF STEMS 3; RPA 104m ² ; RPA RADIUS 5.8m; CANOPY SPREAD N 2m, E 2m, S 2m, W 2m; AMENITY VALUE Low; EASTING/NORTHING point(278375.70 701459.15); USER NAME TD Trees		PRELIMINARY RECOMMENDATIONS Remove Deadwood: Moderate

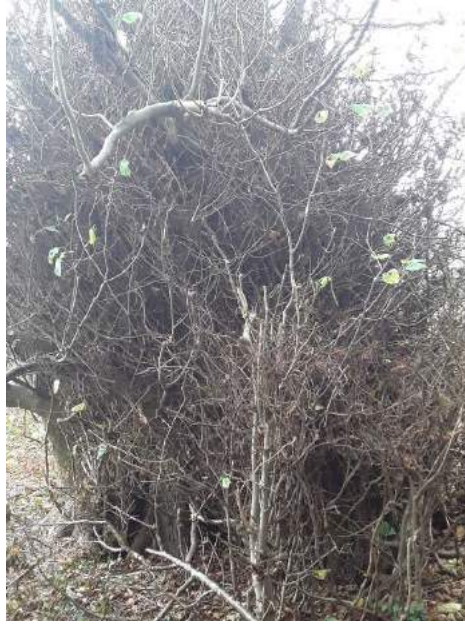
MapNo: 1176 KTId: 110094303
Date: 2018-10-25
ExtId: 1176

1176	Tilia x europaea (Common Lime) (group)	19	Mature	25-10-2019	4	4
	TREE/GROUP TAG 1176; KT ASSET ID 110094303; INSPECTION TYPE Cyclical; TRAFFIC MANAGEMENT REQD None; EST. NUMBER OF TREES 3 SPECIES Tilia x europaea (Common Lime) 100%; PHYSICAL CONDITION Fair; STRUCTURAL_CONDITION Fair; AGE CLASS Mature; GENERAL OBSERVATIONS Large trees with extensive basal growth preventing full inspection. ; EASTING/NORTHING point(278252.46 701562.42); USER NAME TD Trees		PRELIMINARY RECOMMENDATIONS Remove Basal Suckers (3 of group)			
1177	Acer pseudoplatanus (Sycamore)	19	Mature	25-10-2019	4	1
	GENERAL OBSERVATIONS Hardwood decay hollow in lower bole at 1m. Ivy cover from base. CATEGORY C; PHYSICAL_CONDITION Fair; STRUCTURAL_CONDITION Fair; LIFE EXPECTANCY 20-40 years; TREE/GROUP TAG 1177; KT ASSET ID 110094304; INSPECTION TYPE Cyclical; TRAFFIC MANAGEMENT REQD None; NUMBER OF STEMS 1; RPA 471m ² ; RPA RADIUS 12.2m; CANOPY SPREAD N 3m, E 3m, S 5m, W 5m; AMENITY VALUE Medium; EASTING/NORTHING point(278264.35 701551.67); USER NAME TD Trees		PRELIMINARY RECOMMENDATIONS Raise Crown 3m ; Monitor for loss of vigour. Cut ivy at base.

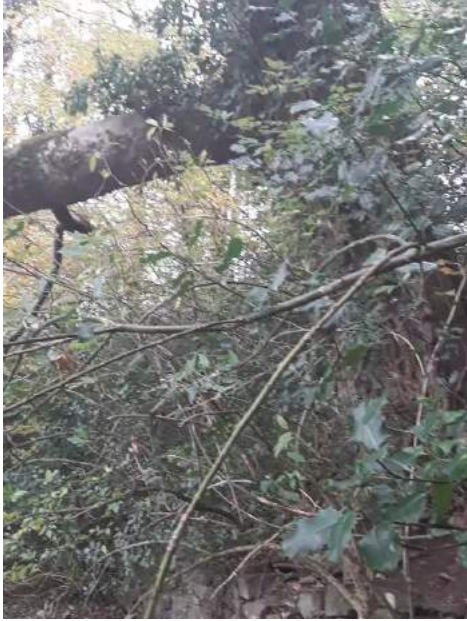
MapNo: 1178 KTId: 110094306
Date: 2018-10-25
ExtId: 1178

1178	Acer pseudoplatanus (Sycamore)	19	Mature	25-10-2019	4	1
	GENERAL OBSERVATIONS Ivy cover from base. Roots have collapsed wall and are undermining banking. Excessive lean west over feild area. CATEGORY B; PHYSICAL_CONDITION Fair; STRUCTURAL_CONDITION Fair; LIFE EXPECTANCY 20-40 years; TREE/GROUP TAG 1178; KT ASSET ID 110094306; INSPECTION TYPE Cyclical; TRAFFIC MANAGEMENT REQD None; NUMBER OF STEMS 1; RPA 567m ² ; RPA RADIUS 13.4m; CANOPY SPREAD N 3m, E 3m, S 3m, W 10m; AMENITY VALUE Medium; EASTING/NORTHING point(278287.06 701545.13); USER NAME TD Trees		PRELIMINARY RECOMMENDATIONS Raise Crown 3m ; Cut ivy at base, monitor for any root plate movement.			
1179	Fagus sylvatica (Common Beech)	20	Mature	25-10-2019	3	10
	GENERAL OBSERVATIONS Mature tree with large buttress. Amileria mellia. Present in buttress roots. Several large limb failures. Dead wood throughout crown. CATEGORY C; PHYSICAL_CONDITION Fair; STRUCTURAL_CONDITION Poor; LIFE EXPECTANCY <10 years; TREE/GROUP TAG 1179; KT ASSET ID 110094308; INSPECTION TYPE Cyclical; TRAFFIC MANAGEMENT REQD None; NUMBER OF STEMS 1; RPA 707m ² ; RPA RADIUS 15.0m; CANOPY SPREAD N 7m, E 4m, S 8m, W 10m; AMENITY VALUE Medium; EASTING/NORTHING point(278330.94 701530.96); USER NAME TD Trees		PRELIMINARY RECOMMENDATIONS Fell Tree ; Plant / Replant Tree

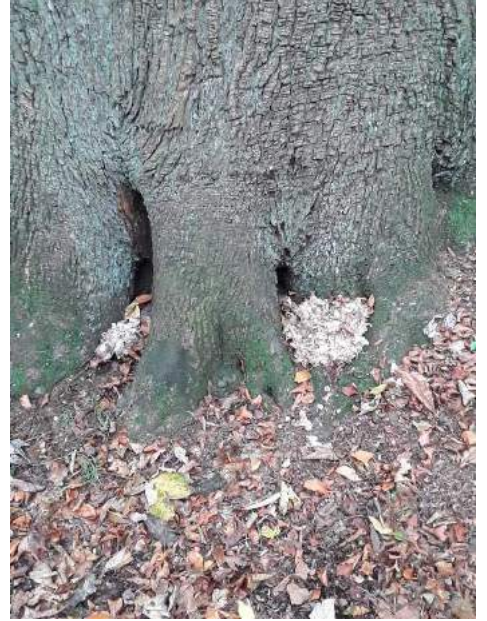
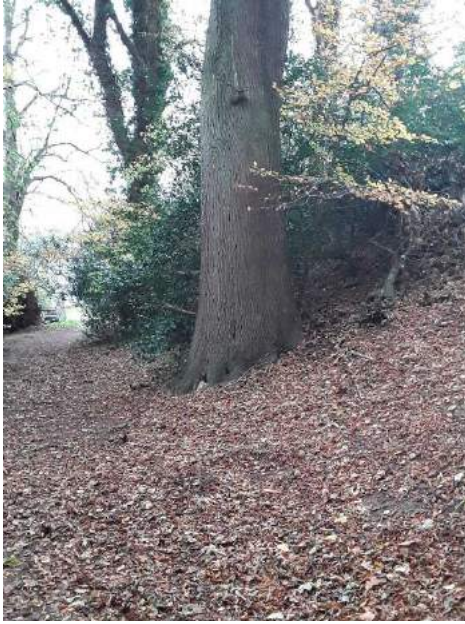
MapNo: 1180 KTId: 110094310
Date: 2018-10-25
ExtId: 1180

1180	Castanea sativa (Sweet Chestnut)	23	OverMature	29-10-2019	3	4
	GENERAL OBSERVATIONS Meripilus giganteus at base. Limb loss to east. Dead wood throughout canopy. CATEGORY B; PHYSICAL_CONDITION Fair; STRUCTURAL_CONDITION Fair; LIFE EXPECTANCY 10-19 years; TREE/GROUP TAG 1180; KT ASSET ID 110094310; INSPECTION TYPE Cyclical; TRAFFIC MANAGEMENT REQD None; NUMBER OF STEMS 1; RPA 707m ² ; RPA RADIUS 15.0m; CANOPY SPREAD N 5m, E 2m, S 8m, W 8m; AMENITY VALUE High; EASTING/NORTHING point(278278.09 701569.82); USER NAME TD Trees		PRELIMINARY RECOMMENDATIONS Remove Deadwood: Moderate ; Monitor yearly for decline. Remove hazard beam over path back to suitable pruning point.			
1181	Acer pseudoplatanus (Sycamore)	17	Mature	29-10-2019	3	3
	GENERAL OBSERVATIONS Tree engulfed by ivy from base. Partial survey. CATEGORY C; PHYSICAL_CONDITION Fair; STRUCTURAL_CONDITION Fair; LIFE EXPECTANCY 20-40 years; TREE/GROUP TAG 1181; KT ASSET ID 110094346; INSPECTION TYPE Cyclical; TRAFFIC MANAGEMENT REQD None; NUMBER OF STEMS 1; RPA 290m ² ; RPA RADIUS 9.6m; CANOPY SPREAD N 3m, E 3m, S 3m, W 3m; CANOPY HEIGHT 3; AMENITY VALUE Medium; EASTING/NORTHING point(278243.45 701589.85); USER NAME TD Trees		PRELIMINARY RECOMMENDATIONS Cut ivy af base. Remove where practicable.

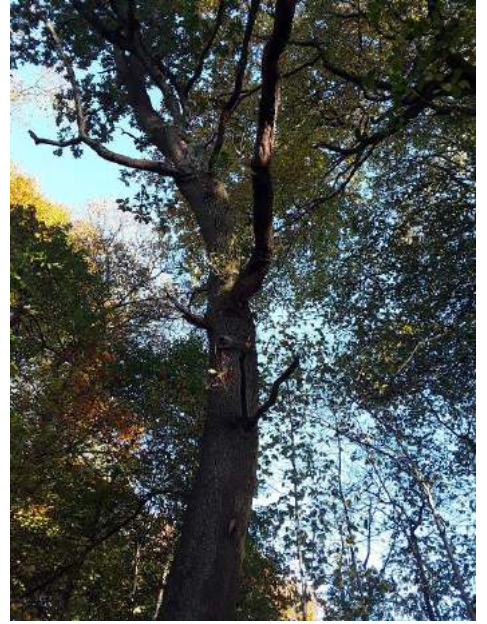
MapNo: 1182 KTId: 110094347
Date: 2018-10-29
ExtId: 1182

1182	Quercus robur (English Oak)	16	Mature	29-10-2019	3	3
	GENERAL OBSERVATIONS Some dead wood over path. phototropic form. CATEGORY B; PHYSICAL_CONDITION Fair; STRUCTURAL_CONDITION Fair; LIFE EXPECTANCY 20-40 years; TREE/GROUP TAG 1182; KT ASSET ID 110094347; INSPECTION TYPE Cyclical; TRAFFIC MANAGEMENT REQD None; NUMBER OF STEMS 1; RPA 72m ² ; RPA RADIUS 4.8m; CANOPY SPREAD N 3m, E 3m, S 4m, W 3m; AMENITY VALUE Medium; EASTING/NORTHING point(278318.52 701556.67); USER NAME TD Trees		PRELIMINARY RECOMMENDATIONS Remove Deadwood: Moderate			
1183	Fagus sylvatica (Common Beech)	19	Mature	29-10-2019	3	4
	GENERAL OBSERVATIONS Large decay hollow in lower bole from ground level to 6m. Good reaction wood supporting. Major limb loss from lower canopy. Good crown vigour. Some small hanging branches in crown. CATEGORY B; PHYSICAL_CONDITION Fair; STRUCTURAL_CONDITION Poor; LIFE EXPECTANCY 10-19 years; TREE/GROUP TAG 1183; KT ASSET ID 110094348; INSPECTION TYPE Cyclical; TRAFFIC MANAGEMENT REQD None; NUMBER OF STEMS 1; RPA 408m ² ; RPA RADIUS 11.4m; CANOPY SPREAD N 4m, E 3m, S 4m, W 4m; AMENITY VALUE Medium; EASTING/NORTHING point(278328.57 701556.47); USER NAME TD Trees		PRELIMINARY RECOMMENDATIONS Remove Deadwood: Moderate ; Thin Crown: Moderate ; Crown Reduction 30% ; 30% reduction to nearest pruning points. Canopy thinning to reduce sail area.

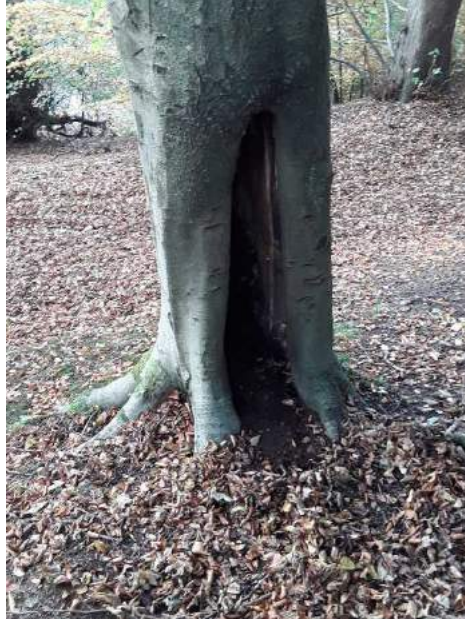
MapNo: 1184 KTId: 110094349
Date: 2018-10-29
ExtId: 1184

1184	Fagus sylvatica (Common Beech)	18	Mature	29-10-2019	3	1
	GENERAL OBSERVATIONS Decay hollow at base of tree. Good reaction wood supporting. Some dead wood over path. CATEGORY B; PHYSICAL_CONDITION Fair; STRUCTURAL_CONDITION Fair; LIFE EXPECTANCY 20-40 years; TREE/GROUP TAG 1184; KT ASSET ID 110094349; INSPECTION TYPE Cyclical; TRAFFIC MANAGEMENT REQD None; NUMBER OF STEMS 1; RPA 366m ² ; RPA RADIUS 10.8m; CANOPY SPREAD N 4m, E 3m, S 3m, W 3m; AMENITY VALUE Medium; EASTING/NORTHING point(278346.11 701540.37); USER NAME TD Trees		PRELIMINARY RECOMMENDATIONS Remove Deadwood: Moderate ; Monitor for loss of vigour.

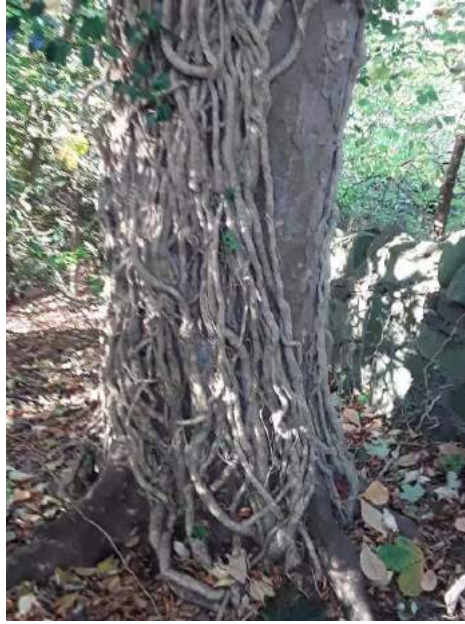
MapNo: 1187 KTId: 110094352
Date: 2018-10-29
ExtId: 1187

1187	Acer pseudoplatanus (Sycamore)	18	Mature	29-10-2019	4	1
	GENERAL OBSERVATIONS Ivy cover from base. Throughout entire tree. CATEGORY B; PHYSICAL_CONDITION Fair; STRUCTURAL_CONDITION Fair; LIFE EXPECTANCY 20-40 years; TREE/GROUP TAG 1187; KT ASSET ID 110094352; INSPECTION TYPE Cyclical; TRAFFIC MANAGEMENT REQD None; NUMBER OF STEMS 1; RPA 282m ² ; RPA RADIUS 9.5m; CANOPY SPREAD N 3m, E 3m, S 3m, W 3m; AMENITY VALUE Medium; EASTING/NORTHING point(278300.20 701584.47); USER NAME TD Trees		PRELIMINARY RECOMMENDATIONS Cut ivy at base of tree.			
1188	Acer pseudoplatanus (Sycamore)	20	Mature	29-10-2019	2	10
	GENERAL OBSERVATIONS Large boundary tree with kretschmeria deausta at base. Major secondary stem loss evident. Tree within target distance of dwelling. CATEGORY U; PHYSICAL_CONDITION Fair; STRUCTURAL_CONDITION Poor; LIFE EXPECTANCY <10 years; TREE/GROUP TAG 1188; KT ASSET ID 110094353; INSPECTION TYPE Cyclical; TRAFFIC MANAGEMENT REQD None; NUMBER OF STEMS 1; RPA 547m ² ; RPA RADIUS 13.2m; CANOPY SPREAD N 10m, E 6m, S 4m, W 5m; AMENITY VALUE Low; EASTING/NORTHING point(278297.40 701616.02); USER NAME TD Trees		PRELIMINARY RECOMMENDATIONS Fell Tree ; Plant / Replant Tree

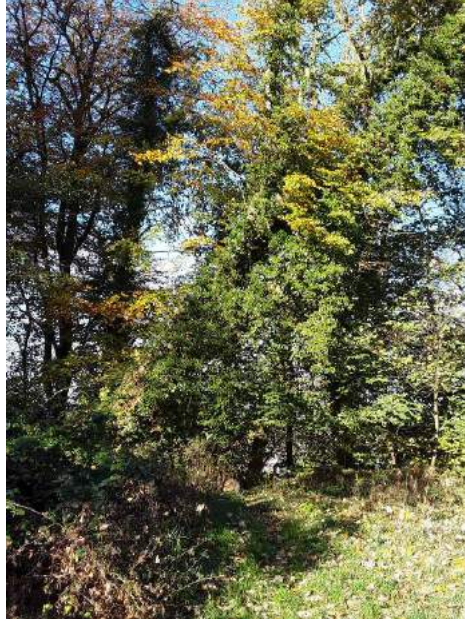
MapNo: 1189 KTId: 110094354
Date: 2018-10-29
ExtId: 1189

1189	Fagus sylvatica (Common Beech)	20	Mature	29-10-2019	2	6
	GENERAL OBSERVATIONS Wind blown tree resting in adjacent sycamore. CATEGORY U; PHYSICAL_CONDITION Poor; STRUCTURAL_CONDITION Poor; LIFE EXPECTANCY <10 years; TREE/GROUP TAG 1189; KT ASSET ID 110094354; INSPECTION TYPE Cyclical; TRAFFIC MANAGEMENT REQD None; NUMBER OF STEMS 1; RPA 290m ² ; RPA RADIUS 9.6m; CANOPY SPREAD N 4m, E 4m, S 4m, W 4m; AMENITY VALUE Low; EASTING/NORTHING point(278328.83 701640.18); USER NAME TD Trees		PRELIMINARY RECOMMENDATIONS Fell Tree ; Plant / Replant Tree			
1190	Fagus sylvatica (Common Beech)	22	OverMature	29-10-2019	3	5
	GENERAL OBSERVATIONS Dence lower crown with branches resting on ground. Hanging branches and dead wood in crown. Large scaffold branches. CATEGORY B; PHYSICAL_CONDITION Fair; STRUCTURAL_CONDITION Fair; LIFE EXPECTANCY >40 years; TREE/GROUP TAG 1190; KT ASSET ID 110094355; INSPECTION TYPE Cyclical; TRAFFIC MANAGEMENT REQD None; NUMBER OF STEMS 1; RPA 707m ² ; RPA RADIUS 15.0m; CANOPY SPREAD N 11m, E 7m, S 9m, W 7m; AMENITY VALUE Medium; EASTING/NORTHING point(278420.22 701626.05); USER NAME TD Trees		PRELIMINARY RECOMMENDATIONS Raise Crown 3m ; Clean all hanging branches and branch failures from the crown.

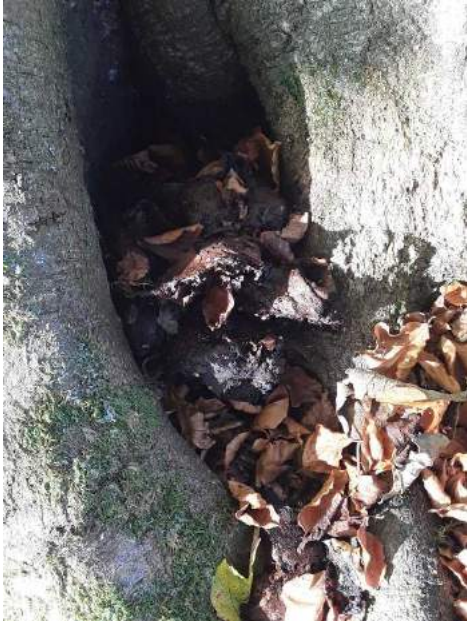
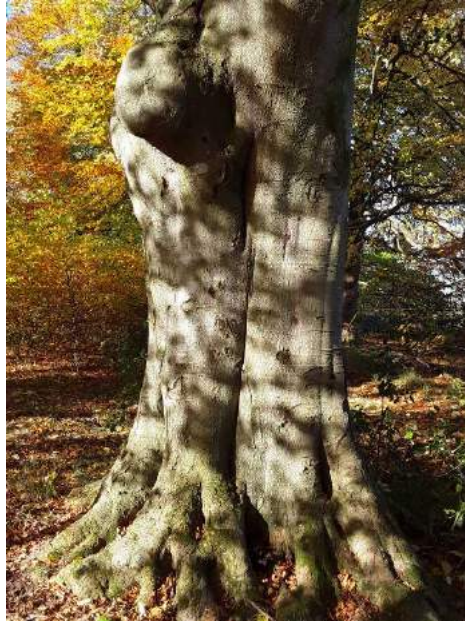
MapNo: 1191 KTIId: 110094356
Date: 2018-10-29
ExtId: 1191

1191	Fagus sylvatica (Common Beech)	20	Mature	29-10-2019	4	1
	GENERAL OBSERVATIONS Meripilus giganteus at base. Crown has good vigour and form. CATEGORY C; PHYSICAL_CONDITION Fair; STRUCTURAL_CONDITION Fair; LIFE EXPECTANCY 10-19 years; TREE/GROUP TAG 1191; KT ASSET ID 110094356; INSPECTION TYPE Cyclical; TRAFFIC MANAGEMENT REQD None; NUMBER OF STEMS 1; RPA 651m ² ; RPA RADIUS 14.4m; CANOPY SPREAD N 5m, E 7m, S 9m, W 5m; AMENITY VALUE Medium; EASTING/NORTHING point(278460.32 701613.41); USER NAME TD Trees		PRELIMINARY RECOMMENDATIONS Monitor yearly for any further reduction in crown vigour.			
1192	Quercus robur (English Oak)	17	OverMature	29-10-2019	4	2
	GENERAL OBSERVATIONS Cambium dysfunction on lower bole from ground level to 4m. Large amounts of dead wood in crown. Epicormic growth throughout canopy. CATEGORY C; PHYSICAL_CONDITION Fair; STRUCTURAL_CONDITION Fair; LIFE EXPECTANCY 10-19 years; TREE/GROUP TAG 1192; KT ASSET ID 110094357; INSPECTION TYPE Cyclical; TRAFFIC MANAGEMENT REQD None; NUMBER OF STEMS 1; RPA 588m ² ; RPA RADIUS 13.7m; CANOPY SPREAD N 7m, E 7m, S 6m, W 2m; AMENITY VALUE Medium; EASTING/NORTHING point(278489.24 701599.87); USER NAME TD Trees		PRELIMINARY RECOMMENDATIONS Remove Deadwood: Moderate

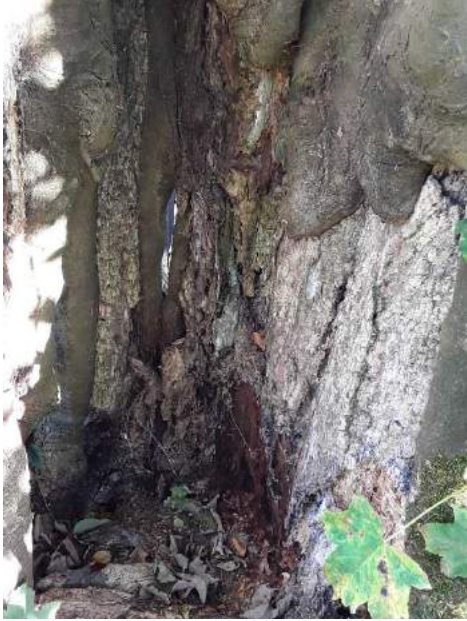
MapNo: 1193 KTIId: 110094359
Date: 2018-10-29
ExtId: 1193

1193	Acer pseudoplatanus (Sycamore)	14	Mature	29-10-2019	2	4
	GENERAL OBSERVATIONS Stem decay at base extensive. Tree supported by cambium and buttresses only. CATEGORY U; PHYSICAL_CONDITION Fair; STRUCTURAL_CONDITION Poor; LIFE EXPECTANCY <10 years; TREE/GROUP TAG 1193; KT ASSET ID 110094359; INSPECTION TYPE Cyclical; TRAFFIC MANAGEMENT REQD None; NUMBER OF STEMS 1; RPA 191m ² ; RPA RADIUS 7.8m; CANOPY SPREAD N 5m, E 5m, S 5m, W 5m; AMENITY VALUE Low; EASTING/NORTHING point(278423.81 701591.62); USER NAME TD Trees		PRELIMINARY RECOMMENDATIONS Fell Tree ; Plant / Replant Tree			
1194	Quercus robur (English Oak)	21	Mature	29-10-2019	3	3
	GENERAL OBSERVATIONS Lower canopy almost completely removed by adjacent tree failure. Large hanging branch at 8m. Upper canopy that was once protected by surrounding trees is now exposed and has a very phototropic form. CATEGORY B; PHYSICAL_CONDITION Fair; STRUCTURAL_CONDITION Fair; LIFE EXPECTANCY 20-40 years; TREE/GROUP TAG 1194; KT ASSET ID 110094360; INSPECTION TYPE Cyclical; TRAFFIC MANAGEMENT REQD None; NUMBER OF STEMS 1; RPA 191m ² ; RPA RADIUS 7.8m; CANOPY SPREAD N 3m, E 3m, S 3m, W 3m; AMENITY VALUE Medium; EASTING/NORTHING point(278390.81 701529.37); USER NAME TD Trees		PRELIMINARY RECOMMENDATIONS Reduce Crown 5m ; Reduce crown to provide resistance to wind loading and possible loss of crown.

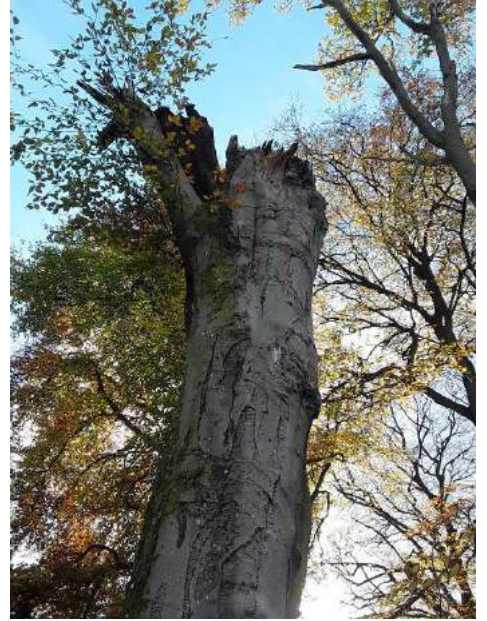
MapNo: 1195 KTIId: 110094361
Date: 2018-10-29
ExtId: 1195

1195	Fagus sylvatica (Common Beech)	12	Mature	29-10-2019	3	2
	GENERAL OBSERVATIONS Remaining stem of a perviously failed beech. Almost no canopy remains. Single scaffold branch over main track. Very large wound at fracture point. CATEGORY U; PHYSICAL_CONDITION Poor; STRUCTURAL_CONDITION Poor; LIFE EXPECTANCY <10 years; TREE/GROUP TAG 1195; KT ASSET ID 110094361; INSPECTION TYPE Cyclical; TRAFFIC MANAGEMENT REQD None; NUMBER OF STEMS 1; RPA 651m ² ; RPA RADIUS 14.4m; CANOPY SPREAD N 0m, E 0m, S 0m, W 0m; AMENITY VALUE Low; EASTING/NORTHING point(278402.00 701536.74); USER NAME TD Trees		PRELIMINARY RECOMMENDATIONS Fell Tree ; Plant / Replant Tree

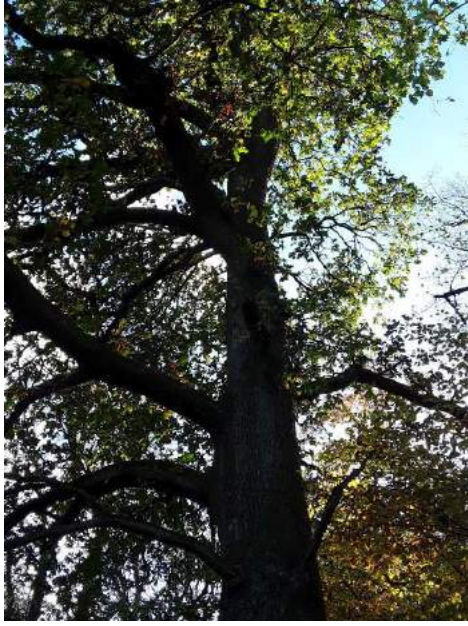
MapNo: 1196 KTIId: 110094362
Date: 2018-10-29
ExtId: 1196

No	Species	Height (m)	Age Class	Next Inspection	Priority	Est. Duration
1196	Quercus robur (English Oak)	20	Mature	29-10-2019	3	2
	GENERAL OBSERVATIONS Large banking tree with dead wood hanging branches. Extend scaffold branch to east at 7m. CATEGORY B; PHYSICAL_CONDITION Fair; STRUCTURAL_CONDITION Fair; LIFE EXPECTANCY >40 years; TREE/GROUP TAG 1196; KT ASSET ID 110094362; INSPECTION TYPE Cyclical; TRAFFIC MANAGEMENT REQD None; NUMBER OF STEMS 1; RPA 275m ² ; RPA RADIUS 9.4m; CANOPY SPREAD N 3m, E 7m, S 9m, W 5m; AMENITY VALUE Medium; EASTING/NORTHING point(278475.88 701536.09); USER NAME TD Trees				PRELIMINARY RECOMMENDATIONS Remove Deadwood: Moderate	
NO REF	Quercus robur (English Oak) (group)	17	Mature	29-10-2019	4	1
	KT ASSET ID 110094358; INSPECTION TYPE Cyclical; TRAFFIC MANAGEMENT REQD None; EST. NUMBER OF TREES 5 SPECIES Quercus robur (English Oak) 100%; PHYSICAL CONDITION Fair; STRUCTURAL CONDITION Fair; AGE CLASS Mature; GENERAL OBSERVATIONS Line of boundary oaks. All have some dead wood in crowns. However provide exellelent habitat for protected spices I.e bats. Outwith the main high usage areas of the woodland, hence limited targets. ; EASTING/NORTHING point(278521.21 701590.47); USER NAME TD Trees				PRELIMINARY RECOMMENDATIONS Monitor for further decline. Aerial protected spices survey required prior to any future works being undertaken. (5 of group)
