Dunblane Allan Water Restoration Project

Repair and Maintenance Strategy

September 2013

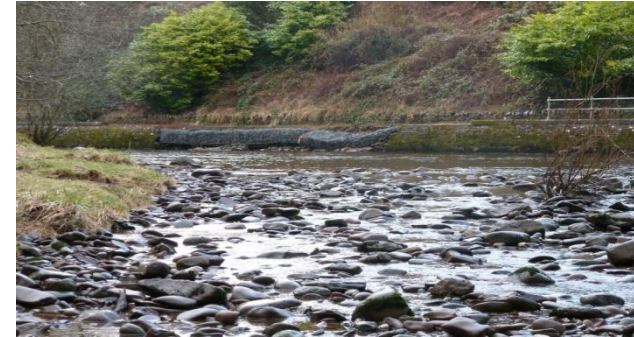
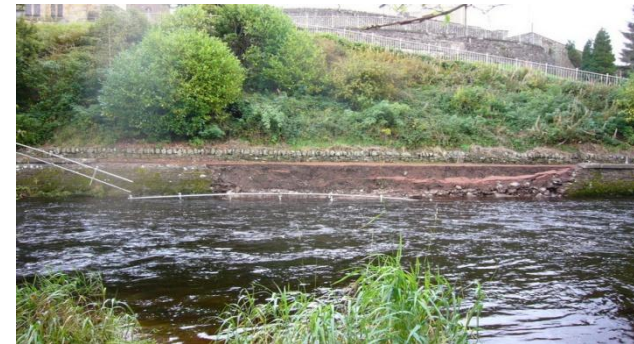
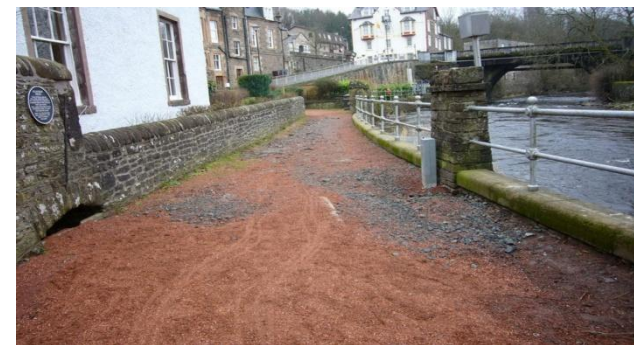
- Lower reaches of Allan Water canalised through the centre of Dunblane in 1800s due to railway and town infrastructure.
- Canalised sections have suffered high levels of deposition in times of spate. Worse since 2006?
- Erosion and disposition effects are much greater in canalised sections.
- Higher river velocities in canalised sections have recently led to voids and failures of existing masonry walls.
- Overtopping of canalised walls has caused flooding and damages to homes and footpaths.

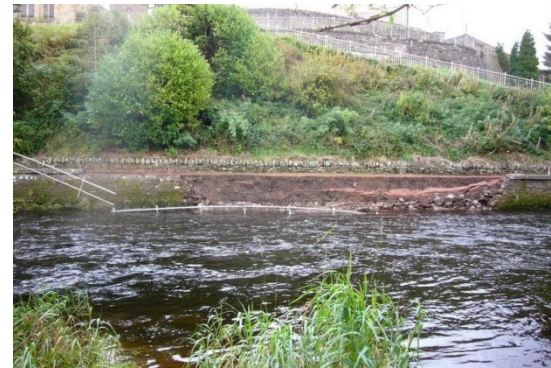
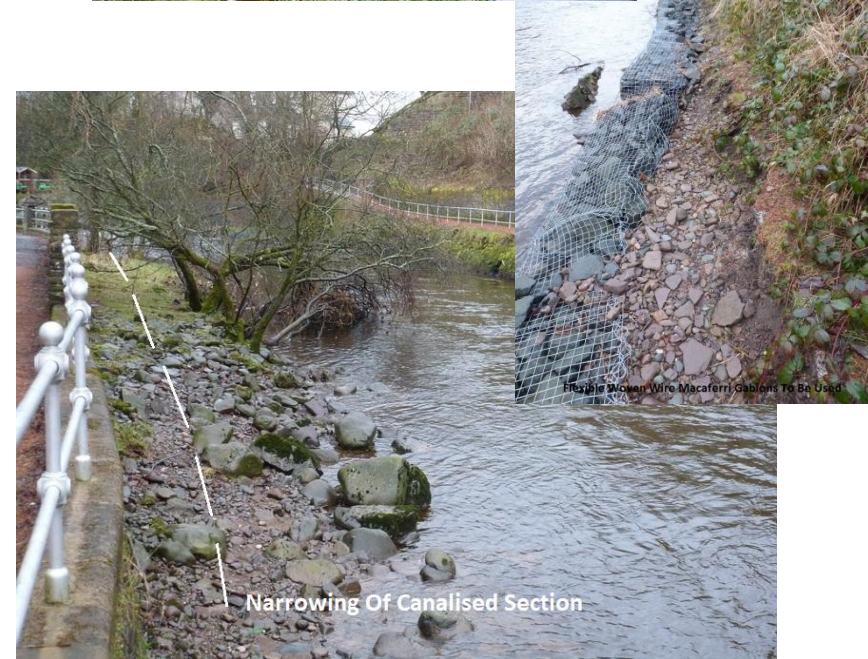
- Cross sections and flood bypass channels are heavily choked.
- The cross sectional area in the river section under the cathedral has lost 10 – 15% of cross sectional area.
- Trees have grown in the raised beach deposits further reducing area.
- Deposits have increased velocity on the opposite edges, exacerbating erosion and contributing to the collapse of footpath walls.
- The loss of river cross section has contributed to overtopping of the footpath walls.

- Cut down and remove all trees within the canalised section and grub roots out.
- Widen the river on the Memorial Park side and reinforce with boulders from river.
- Bulldoze out bypass channel and use material to form berm in Memorial Park.
- Arrange boulders in riverbed to form weirs and control river velocities.
- Place large boulders at edge by wall to reduce scour velocities.
