LAIGHILLS PARK INSPECTION

DOC REF: 12770/DK/198 REVISION A

CLIENT: Stirling council

ENGINEER: Millard Consulting
Seabraes
18 Greenmarket
Dundee
DD1 4QB

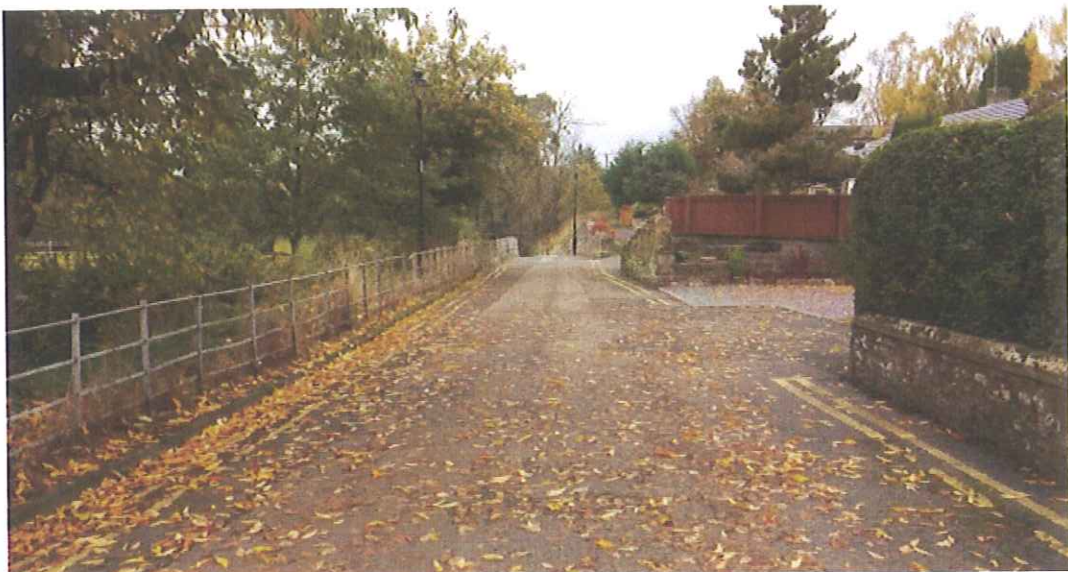
Photograph 1

A small soft spot is evident at the end of the double yellow lines. This may be connected to the water supply to the adjacent house.

A stone retaining wall extends down the north side of the access to the railway bridge. The wall has been repaired in the past. The surfacing at the foot of the wall has been eroded. It is assumed water coming down and also through the wall has gotten below the surfacing at the interface, weakening the material and causing it to break up.

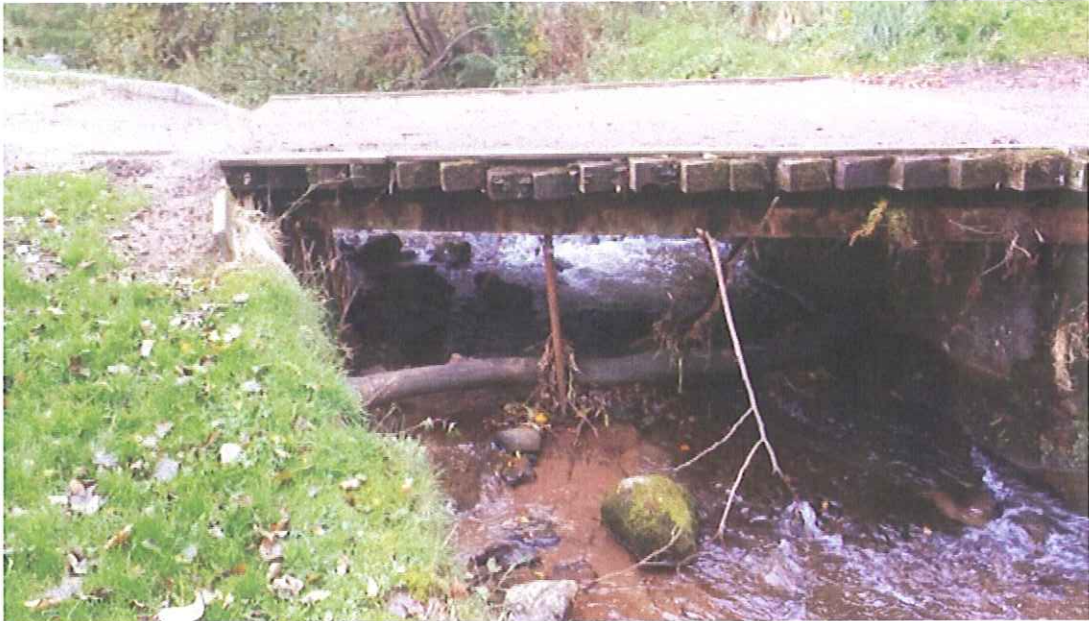
Photograph 10 – Downstream View

The photographs taken upstream give a general indication of the approaches to the bridge which are generally poor. The run-off from the access drains into the burn at each side of the bridge. The ground on either side was found to be uneven with standing water noted.

- A new bridge structure be constructed to replace the existing. The form of construction should be decided by the Client and Architect as it may be desirable to have a timber bridge or a timber deck on steel beams. We would be pleased to provide additional information if required.

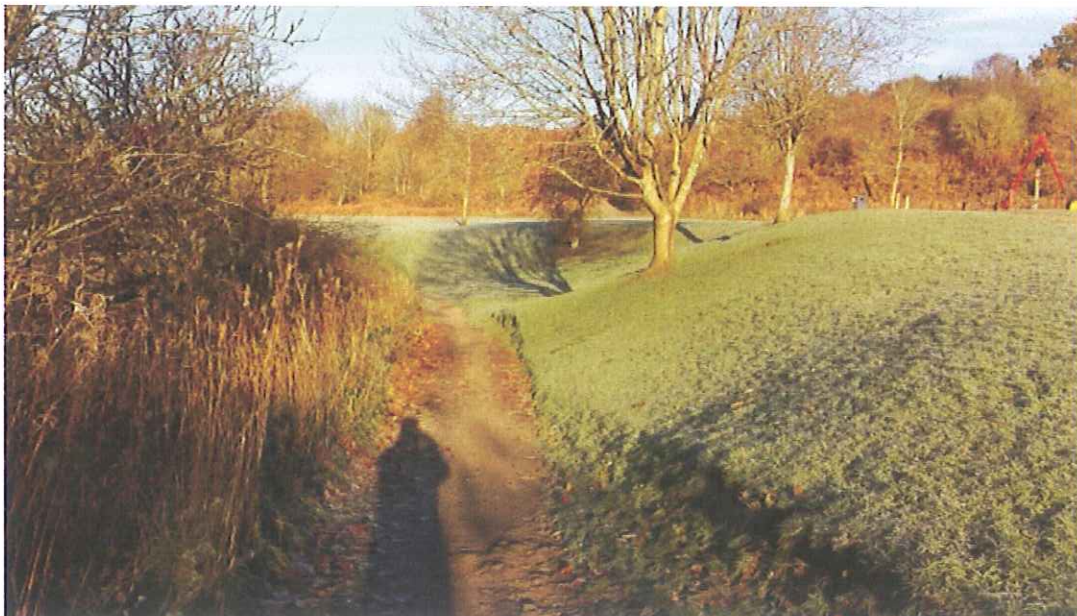
Photograph 21

Continuing west from the access road, a well worn dirt track forms the first section of a pedestrian route along Allan Water to the low level football pitch. The initial section lies between the slope to the playpark and Allan Water. The toe of the slope has slipped in various locations. It appears to have slipped sometime ago as the ground is covered in grass, with little evidence of fresh movement. The surface of the path itself is hard packed, worn soil with many exposed stones. Exposed rock is also visible. The exposed stone and rock create a slightly uneven surface with little or no loose materials.

- The initial worn section of path could be improved. A path of timber edging infilled with sub-base material, sealed topped with fine gravel or whin dust would create a smooth even path.
- The raising of the path level will also help reduce the slope and more importantly the movement at the toe of the slope.
- The areas of slope that have slipped should be either regraded to reduce the gradient, or, small retaining walls constructed using natural materials.

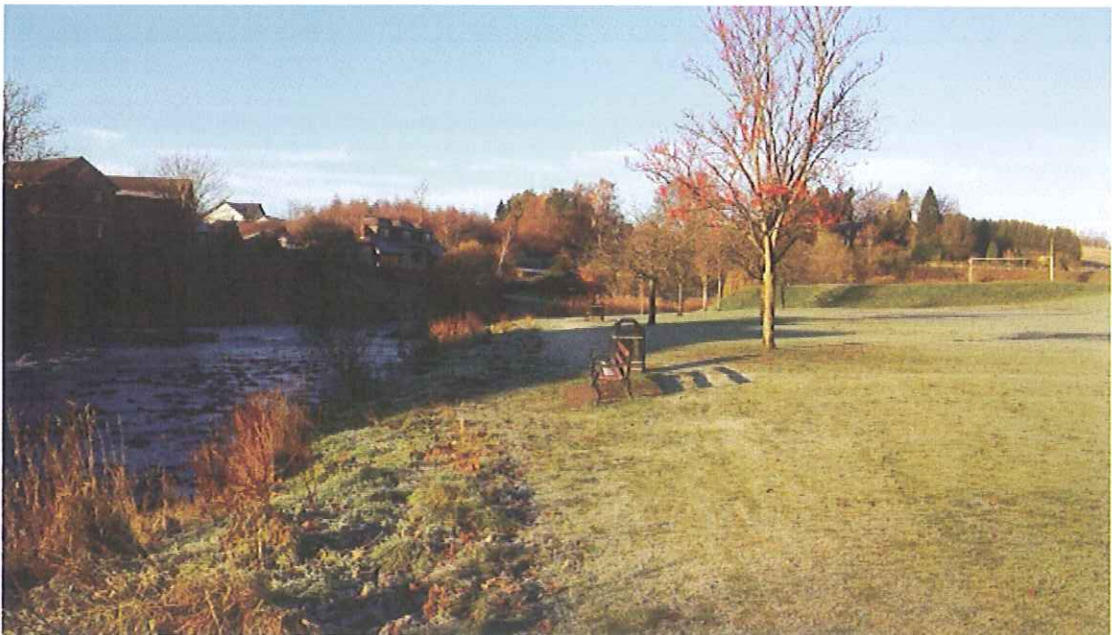
Photograph 23

The worn path ends as the path reaches the flat area between the playpark and football pitch, where the entire area is covered by grass with an open aspect to Allan Water.

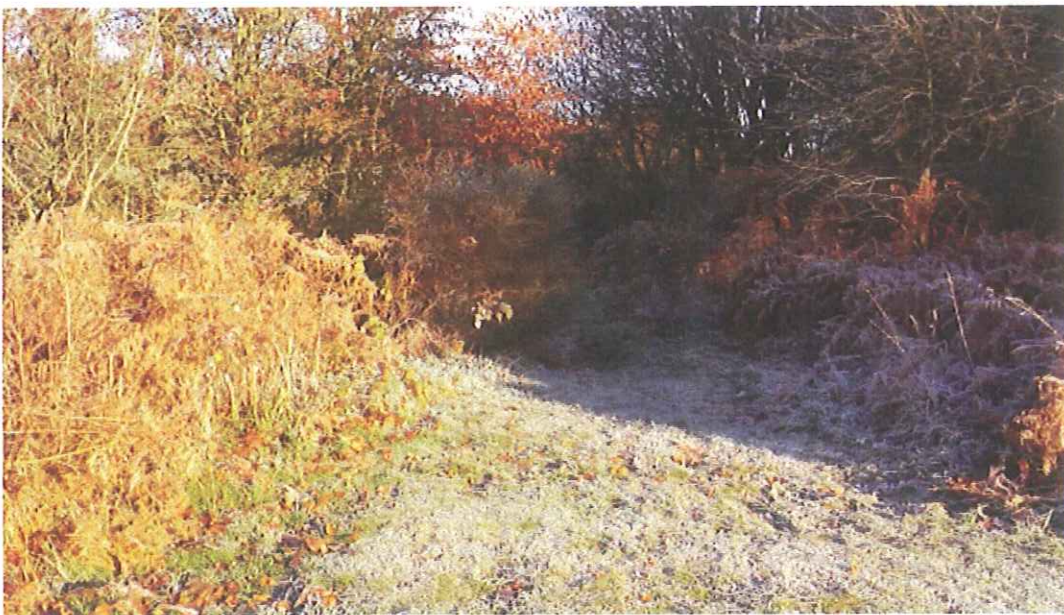
Photograph 25

Progressing around the pitch the path continues in grass. The chestnut pale fence between the pitch and path is in very poor condition, but poses no risk to pedestrians.

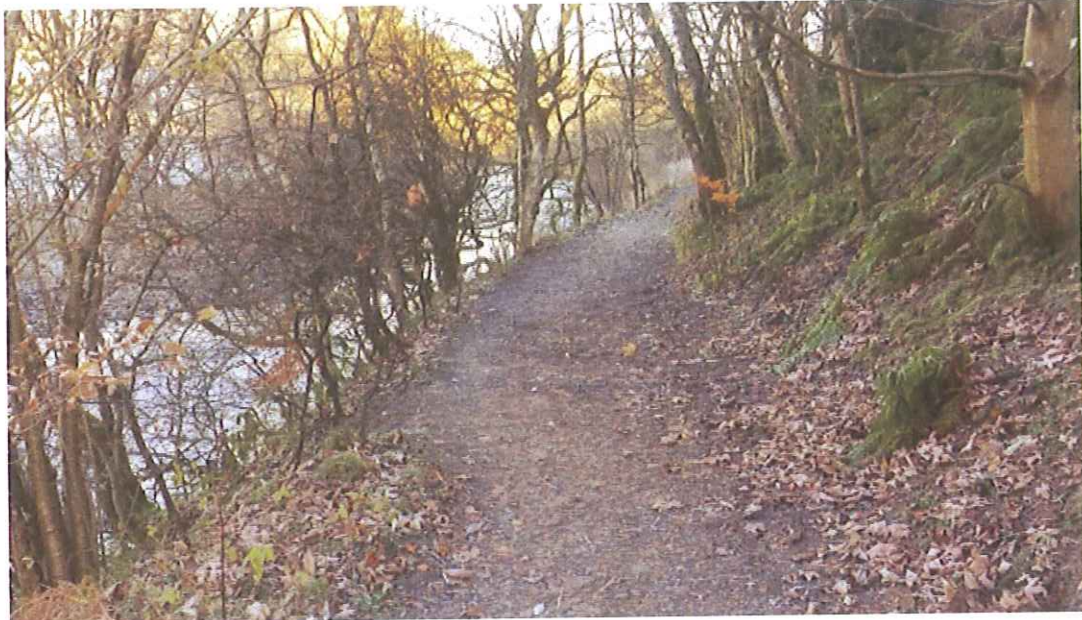
Photograph 26

- 3.5.1 The path continues northwards along the bank of Allan Water on the Parks western boundary. The path is a hard packed, worn track, benched into the hillside, its width approximately 1.8 – 2m in places. The slope to Allan Water being relatively steep.

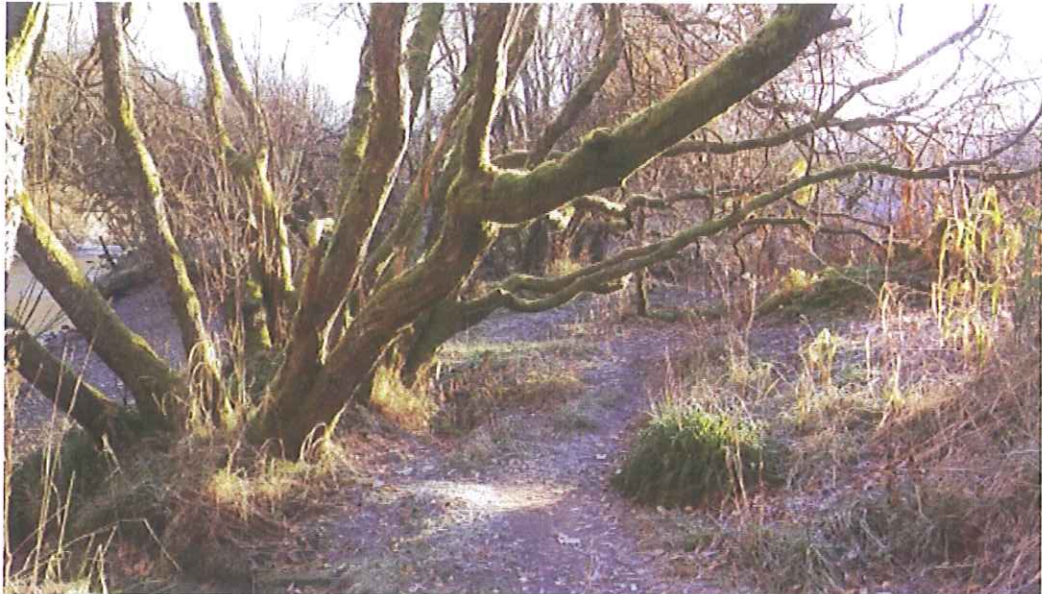
Photograph 30

The path quickly becomes very rough and uneven as it progresses to the bend in the river, no more than single file width available with numerous tripping hazards and trees blocking the path.

There is an obvious route to take as the tracks are visible. Fluctuating water levels in the river may have had an effect on the path causing deep rutting, exposed pebbles and boulders, and washing out of materials.

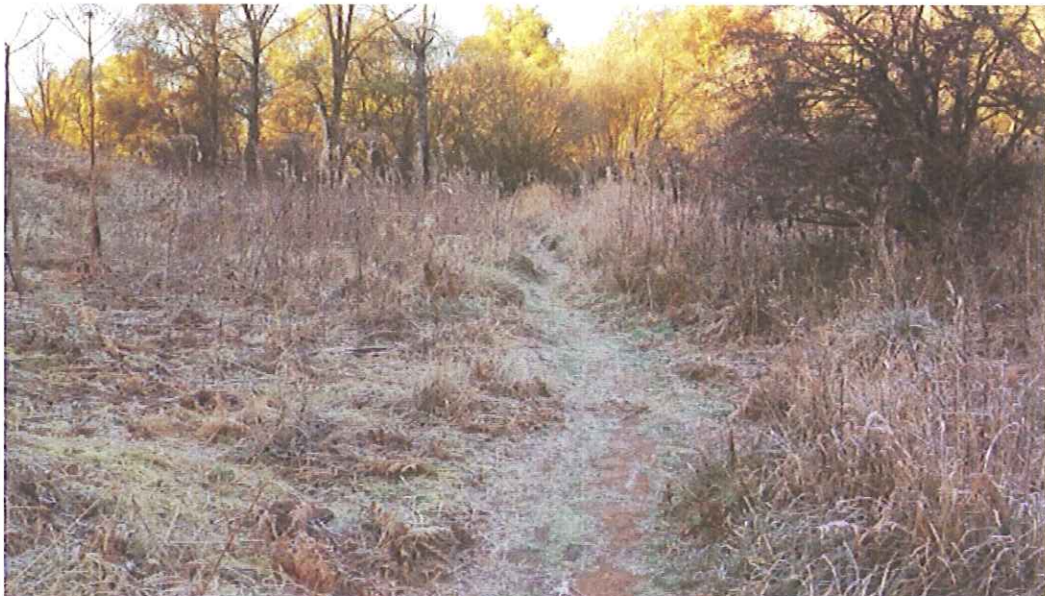
Photograph 31

The path follows the bend of the river from west to east where it doubles back on itself through an area of Giant Hogweed.

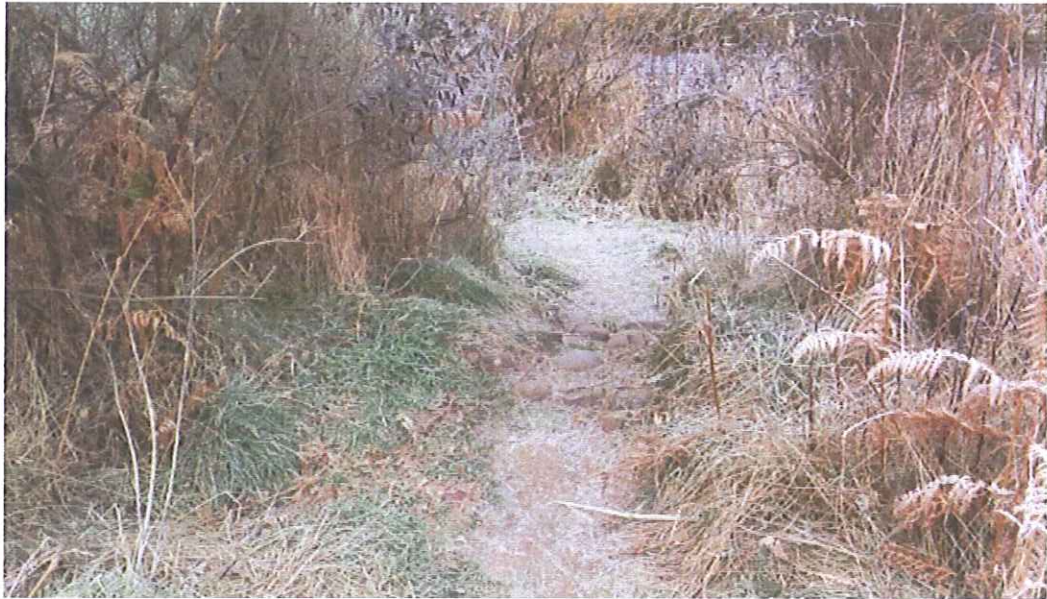
Photograph 32

3.5.2 This section is relatively flat and in good condition. It is perhaps a relatively new track worn out by pedestrians avoiding the now dangerous route around the bend of the river. As the path heads back westwards it meets the original track with some steps created using boulders. It would appear that this has now become the common route to take avoiding the original route along the river bank, although the Giant Hogweed may pose a safety risk during the growing season.

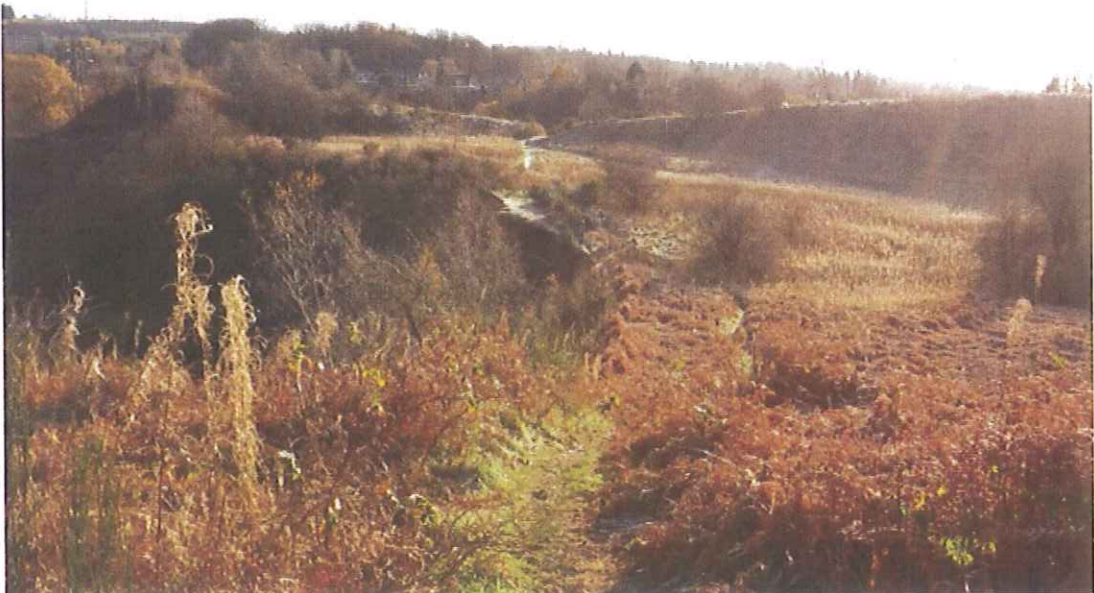
Photograph 36

3.6.1 From the high point looking east, the worn path can be clearly seen to the point it breaks through the ridge and continues to the footbridge over by the railway line. There is a very steep decent down to the flat plateau from this direction.

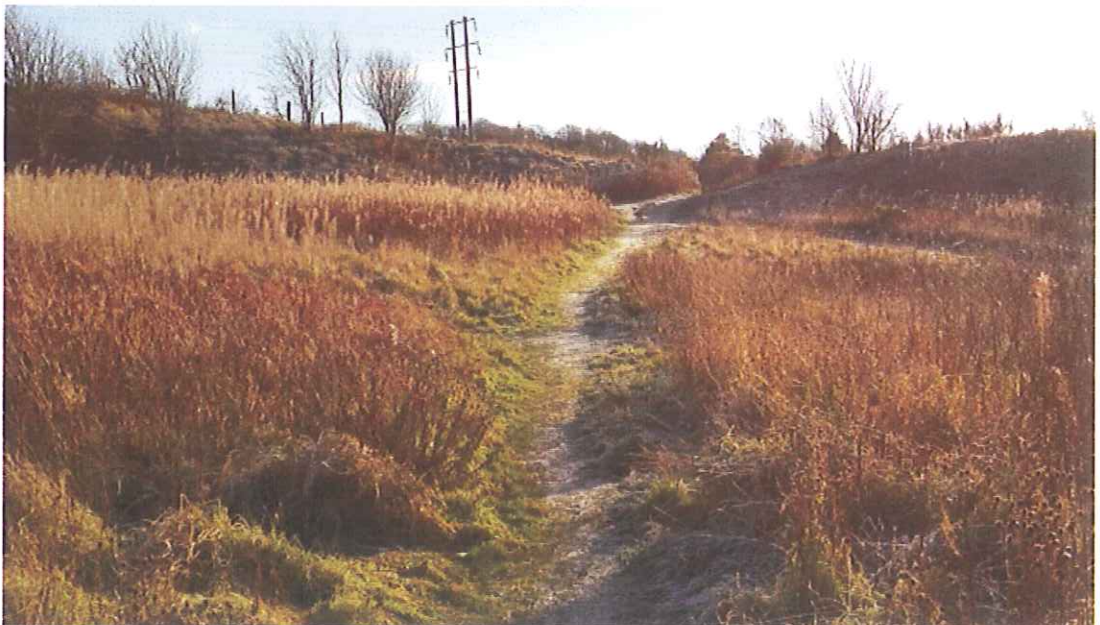
Photograph 40

The path moves away from the river, heading through the gap in the ridge towards the footbridge, all paths in this area are grass tracks.

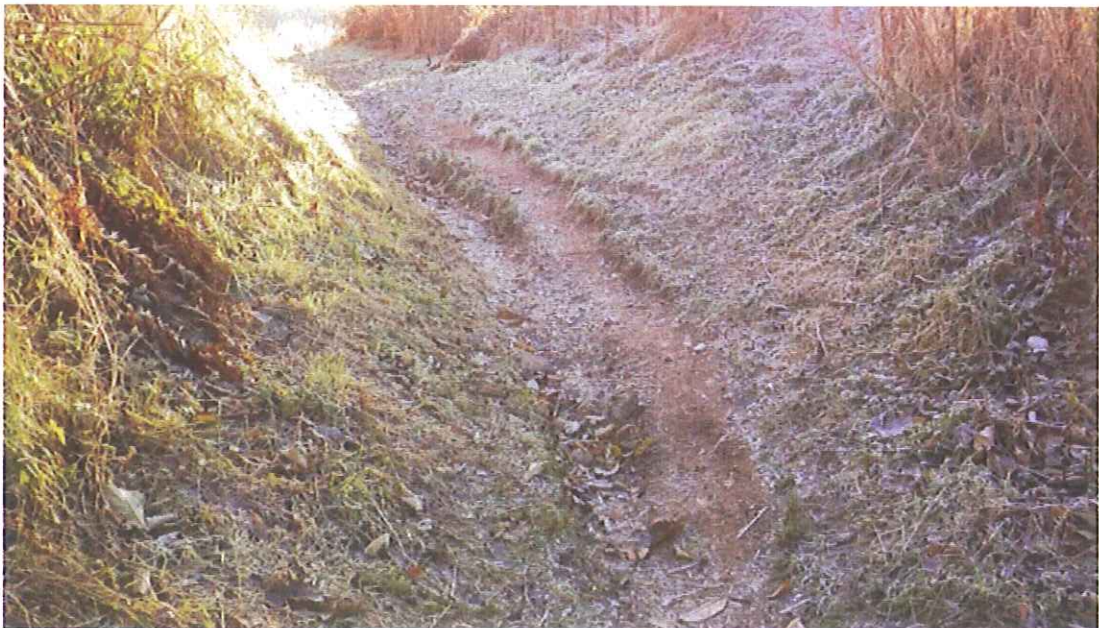
Photograph 49

- 3.11.1 The grass track from the BMX heads northwards through a wooded area. The grass path becomes worn to a narrow dirt track below the tree canopy, badly rutted in places. The track becomes very narrow with steep sides.

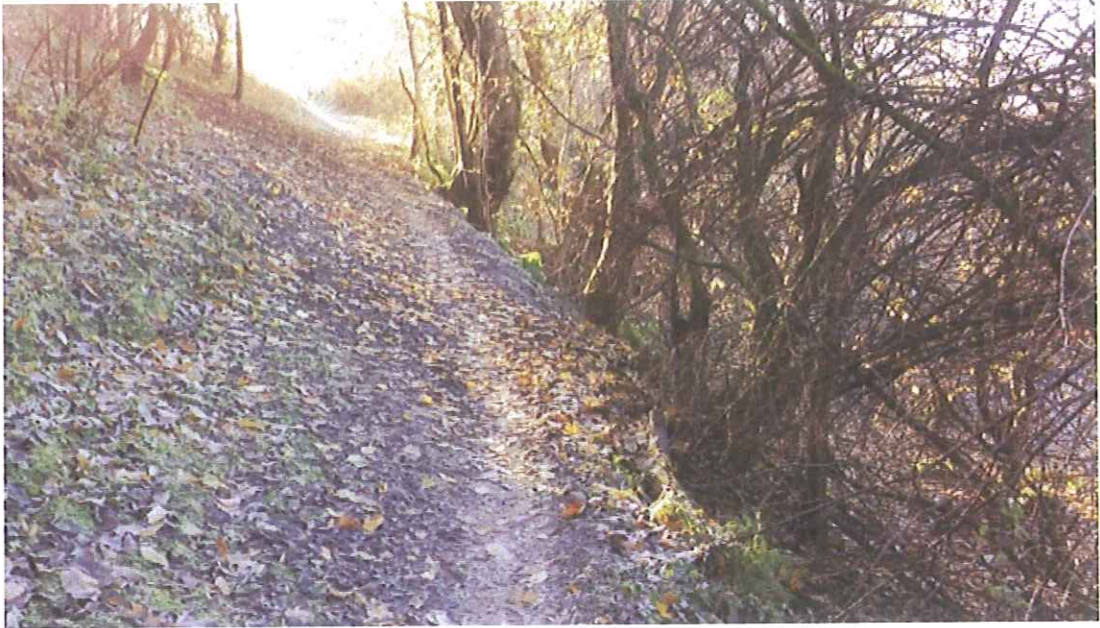
Photograph 50

The steep side consists of scrub and trees dropping away to a lower level. There is only room for single file movements.

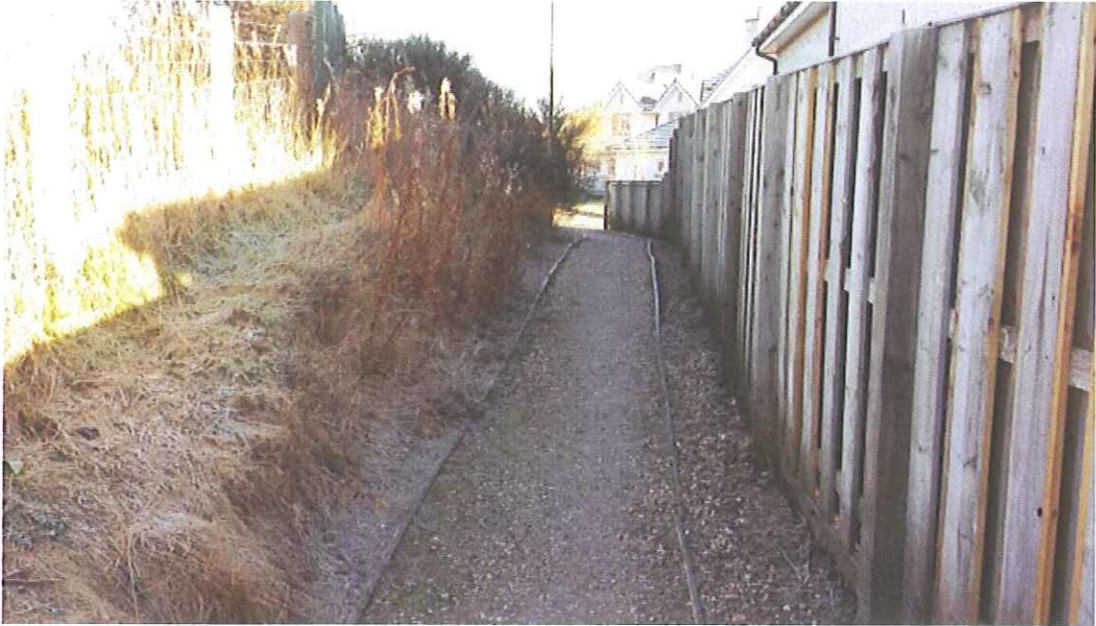
Photograph 54

Once up at the level of the house plot a formal path has been constructed, albeit now in relatively poor condition but with no real problems.

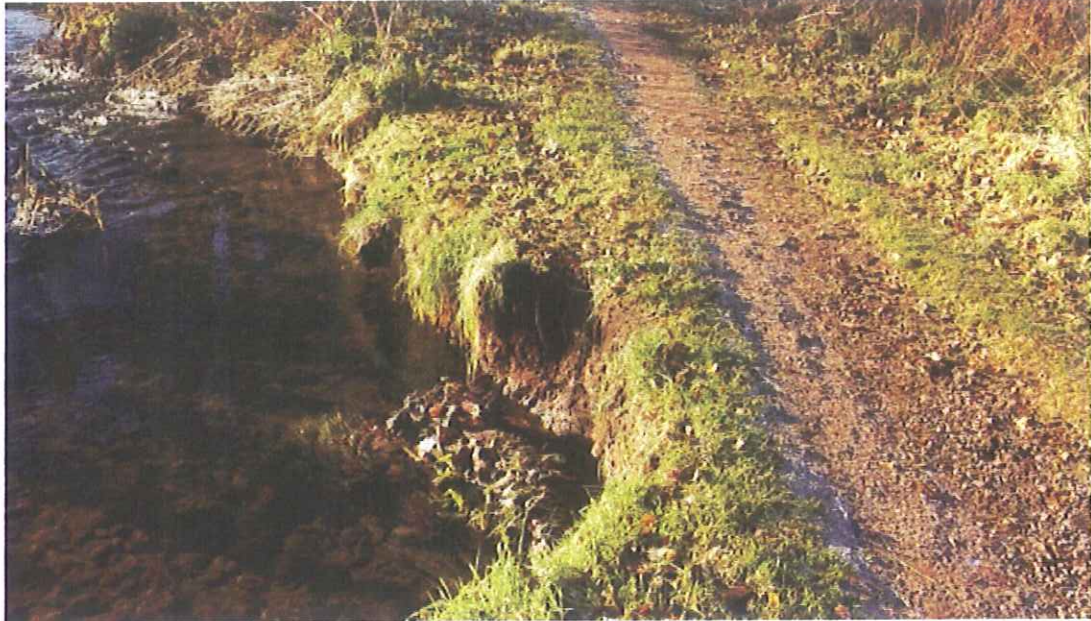
Photograph 57

3.13.1 This is a worn pedestrian track heading east along the route of the Scouring Burn. No formal construction has taken place. In some areas the path is very low lying close to the burn, causing flooding issues. Part of the Burn closest to the path has been eroded, creating an overhang that has recently suffered from minor collapse.

- Where the burn is eroding the banks close to the path, a form of protection should be constructed such as gabion baskets. This will also provide stability to the path
