TD TREE & LAND SERVICES LTD

Visual Tree Assessment (Type 1) Arboricultural Hazard and Risk Report Woodland Management Strategy

Client: Holmehill Ltd
24 Dargai Terrace
Dunblane
FK15 0AU

Site: Holme Hill Community Woodland
Dunblane
Stirlingshire

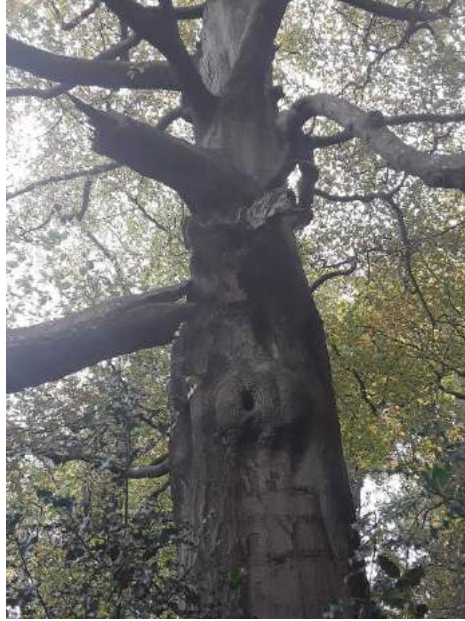
MapNo: 1139 KTId: 110094307
Date: 2018-10-25
ExtId: 1139

GENERAL OBSERVATIONS Tree on wall top. With exposed roots. Branch collar decay hollow in lower bole at 3m. Failed branch sitting up against tree. CATEGORY B; PHYSICAL_CONDITION Fair; STRUCTURAL_CONDITION Fair; LIFE EXPECTANCY >40 years; TREE/GROUP TAG 1139; KT ASSET ID 110094307; INSPECTION TYPE Cyclical; TRAFFIC MANAGEMENT REQD None; NUMBER OF STEMS 1; RPA 598m ² ; RPA RADIUS 13.8m; CANOPY SPREAD N 5m, E 5m, S 7m, W 8m; AMENITY VALUE Medium; EASTING/NORTHING point(278299.55 701540.13); USER NAME TD Trees		PRELIMINARY RECOMMENDATIONS Remove Deadwood: Moderate ; Raise Crown 5m ; Remove hanging branches. Balance lower crown to counteract the loss off the western limb.			
1141	Acer pseudoplatanus (Sycamore)	19	Mature	25-10-2019	4	1
	GENERAL OBSERVATIONS Ivy cover from base. Roots have collapsed wall and are undermining banking. Exsessive lean west over feild area. CATEGORY B; PHYSICAL_CONDITION Fair; STRUCTURAL_CONDITION Fair; LIFE EXPECTANCY 20-40 years; TREE/GROUP TAG 1141; KT ASSET ID 110094305; INSPECTION TYPE Cyclical; TRAFFIC MANAGEMENT REQD None; NUMBER OF STEMS 1; RPA 547m ² ; RPA RADIUS 13.2m; CANOPY SPREAD N 3m, E 3m, S 3m, W 10m; AMENITY VALUE Medium; EASTING/NORTHING point(278273.55 701548.87); USER NAME TD Trees		PRELIMINARY RECOMMENDATIONS Cut ivy at base. Monitor for signs of root plate movement.

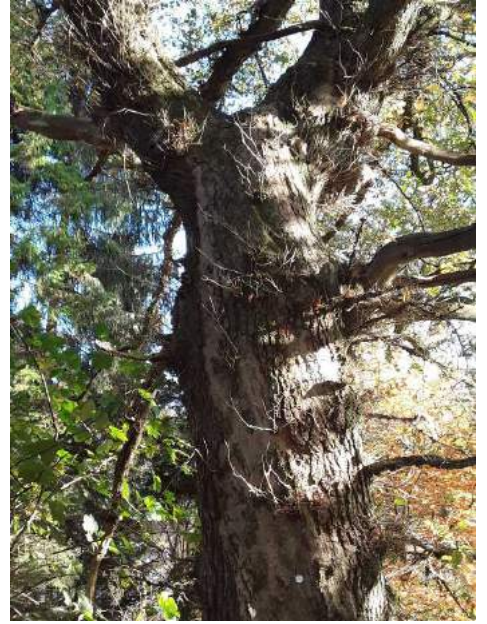
MapNo: 1193 KTIId: 110094359
Date: 2018-10-29
ExtId: 1193

1193	Acer pseudoplatanus (Sycamore)	14	Mature	29-10-2019	2	4
	GENERAL OBSERVATIONS Stem decay at base extensive. Tree supported by cambium and buttresses only. CATEGORY U; PHYSICAL_CONDITION Fair; STRUCTURAL_CONDITION Poor; LIFE EXPECTANCY <10 years; TREE/GROUP TAG 1193; KT ASSET ID 110094359; INSPECTION TYPE Cyclical; TRAFFIC MANAGEMENT REQD None; NUMBER OF STEMS 1; RPA 191m ² ; RPA RADIUS 7.8m; CANOPY SPREAD N 5m, E 5m, S 5m, W 5m; AMENITY VALUE Low; EASTING/NORTHING point(278423.81 701591.62); USER NAME TD Trees		PRELIMINARY RECOMMENDATIONS Fell Tree ; Plant / Replant Tree			
1194	Quercus robur (English Oak)	21	Mature	29-10-2019	3	3
	GENERAL OBSERVATIONS Lower canopy almost completely removed by adjacent tree failure. Large hanging branch at 8m. Upper canopy that was once protected by surrounding trees is now exposed and has a very phototropic form. CATEGORY B; PHYSICAL_CONDITION Fair; STRUCTURAL_CONDITION Fair; LIFE EXPECTANCY 20-40 years; TREE/GROUP TAG 1194; KT ASSET ID 110094360; INSPECTION TYPE Cyclical; TRAFFIC MANAGEMENT REQD None; NUMBER OF STEMS 1; RPA 191m ² ; RPA RADIUS 7.8m; CANOPY SPREAD N 3m, E 3m, S 3m, W 3m; AMENITY VALUE Medium; EASTING/NORTHING point(278390.81 701529.37); USER NAME TD Trees		PRELIMINARY RECOMMENDATIONS Reduce Crown 5m ; Reduce crown to provide resistance to wind loading and possible loss of crown.

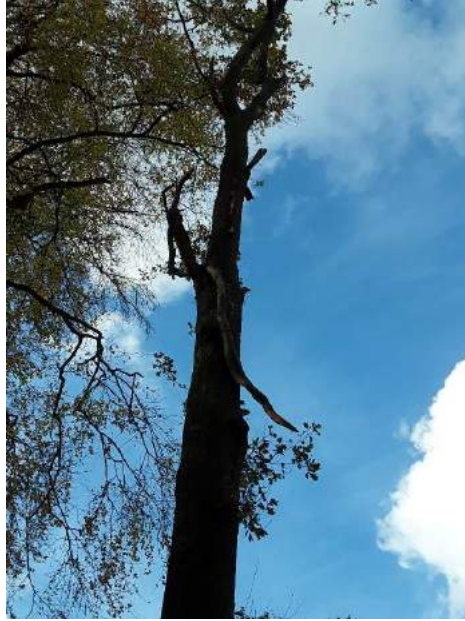
MapNo: 1195 KTIId: 110094361
Date: 2018-10-29
ExtId: 1195

1195	Fagus sylvatica (Common Beech)	12	Mature	29-10-2019	3	2
	GENERAL OBSERVATIONS Remaining stem of a perviously failed beech. Almost no canopy remains. Single scaffold branch over main track. Very large wound at fracture point. CATEGORY U; PHYSICAL_CONDITION Poor; STRUCTURAL_CONDITION Poor; LIFE EXPECTANCY <10 years; TREE/GROUP TAG 1195; KT ASSET ID 110094361; INSPECTION TYPE Cyclical; TRAFFIC MANAGEMENT REQD None; NUMBER OF STEMS 1; RPA 651m ² ; RPA RADIUS 14.4m; CANOPY SPREAD N 0m, E 0m, S 0m, W 0m; AMENITY VALUE Low; EASTING/NORTHING point(278402.00 701536.74); USER NAME TD Trees		PRELIMINARY RECOMMENDATIONS Fell Tree ; Plant / Replant Tree
